Eastern Home Inspections of NJ
3070 Route 206
Columbus, NJ 08022
609-291-1300

Client Information: Record Number E091319A

Doe, John & Mary
1 Sample Court
Sample City, NJ 00000

Inspected 9/13/19 2:00 PM

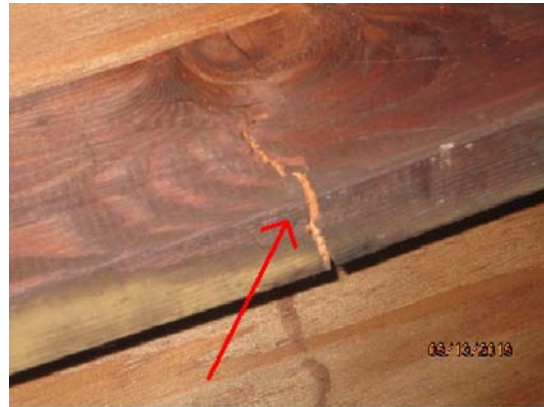
Split rafter noted at left side rear in garage.

Recommend having a qualified contractor repair as needed prior to closing.

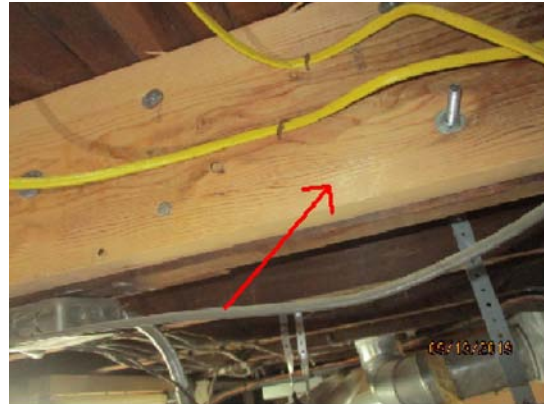
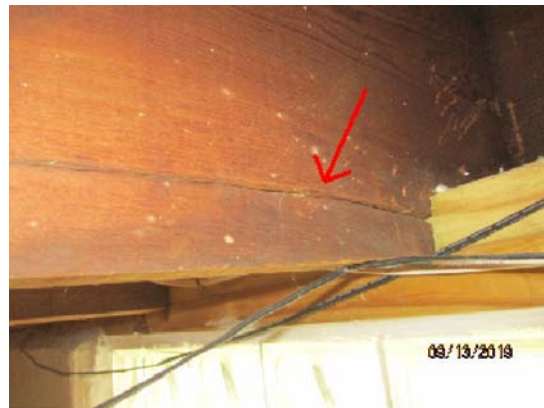
One joist at left side near rear has been repaired in a workman like fashion.

Split joist at right side near the rear.

Recommend having a qualified contractor repair as needed prior to closing.

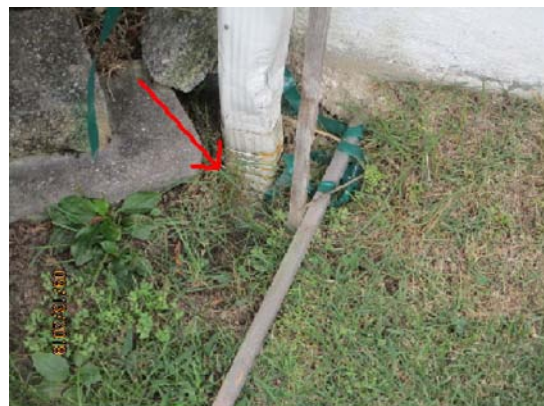
Front right downspout appears to be going to an underground drain. Unable to determine.

Recommend having a qualified contractor evaluate and if it is not going to an underground drainage system have it repaired as needed to prevent water intrusion prior to closing.

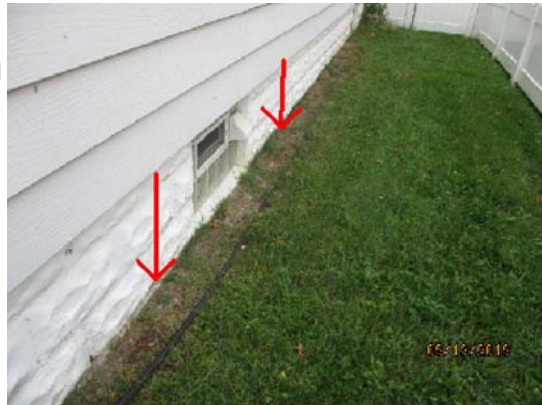
A negative pitch was noted within five feet of the foundation which will cause ponding. A slope of 1 inch per foot for a minimum of five feet away from foundation is necessary to shed the water away from the foundation.

Recommend having a qualified contractor repair as needed prior to closing.

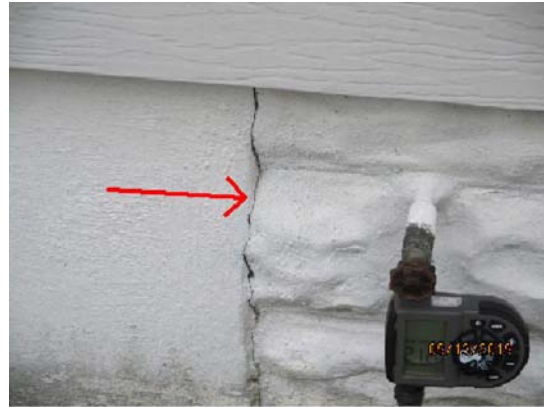
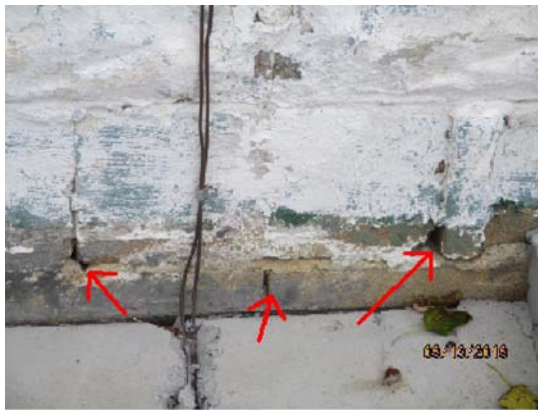
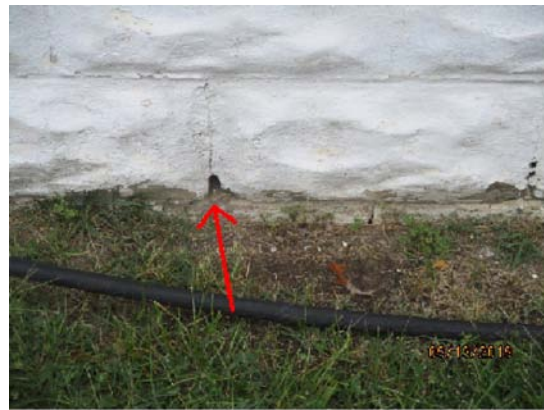
Exposed Foundation

Several cracks and missing mortar noted on exposed foundation walls. No deflection. The cracks appear to be static and do not threaten the integrity of the structure.

Recommend having a qualified contractor repair as needed to prevent water intrusion prior to closing.

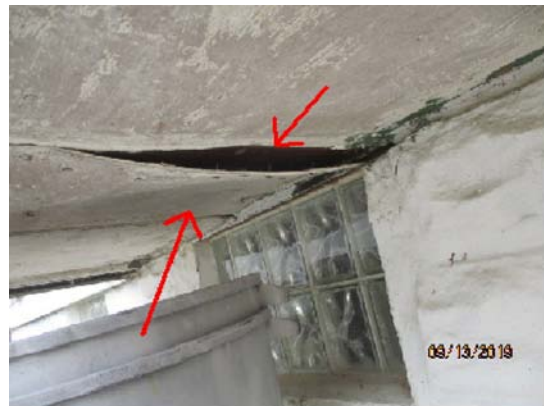
Soffit/Fascia

Left side middle the soffit is sagging and there is a large gap noted.

Recommend having a qualified contractor repair as needed to prevent water, bird and animal intrusion prior to closing.

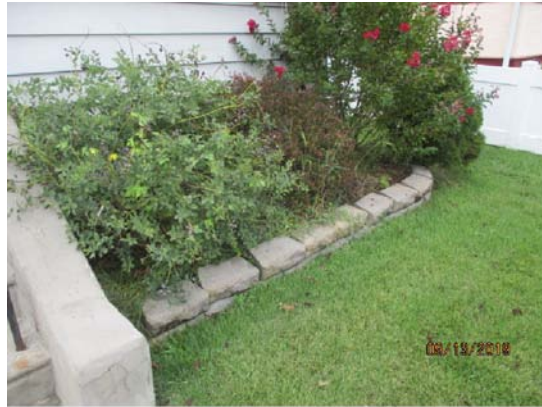
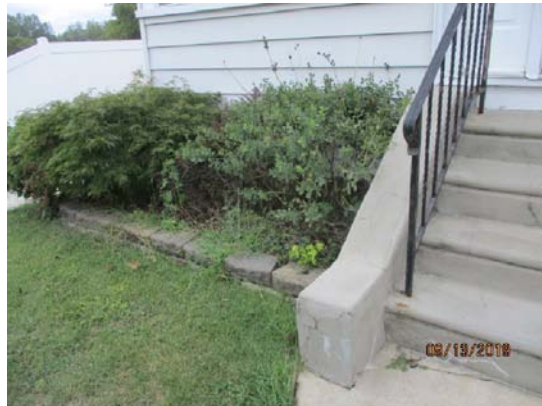
Vegetation noted touching the house. This limits our view.

Recommend having a qualified contractor remove the vegetation as needed prior to closing.

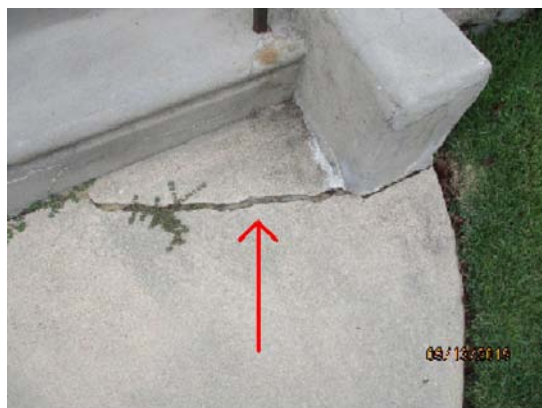
Walks

Crack noted on front walk.

Recommend having a qualified contractor seal crack to prevent trip hazard and water penetration prior to closing.

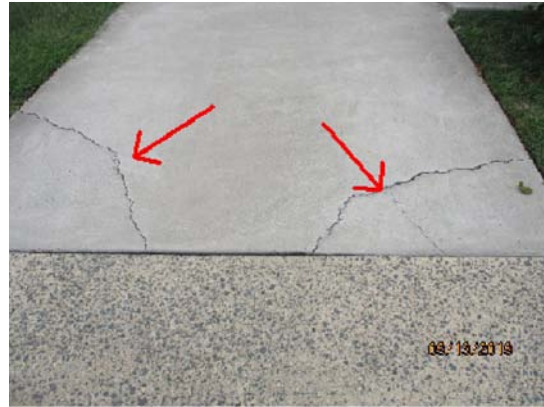
Driveway

Several cracks noted on driveway.

Recommend having a qualified contractor seal cracks to prevent trip hazard and water penetration prior to closing.

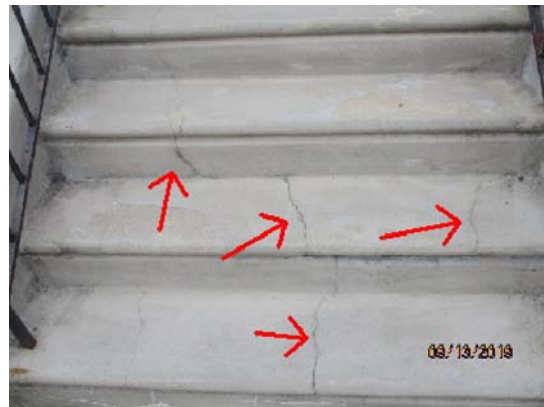
Steps

Front concrete steps have cracks noted.

Recommend having a qualified contractor seal cracks as needed to prevent water intrusion prior to closing.

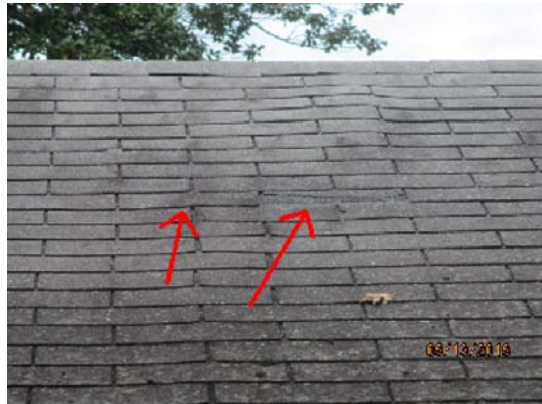
Several lifted shingles and missing shingle noted on garage roof.

Recommend having a qualified roofing contractor evaluate and repair or replace as needed to prevent water intrusion prior to closing.

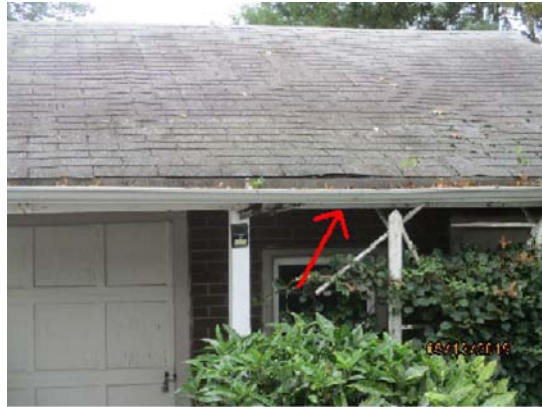
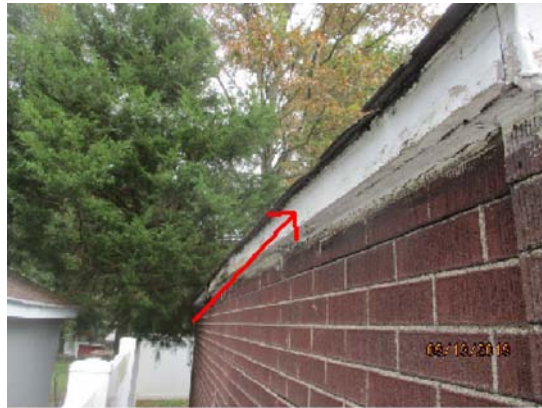
Garage Type

Garage front gutter is sagging in the middle and rear the gutter and downspouts are missing. Gutters and downspouts are needed to move water away from the foundation wall at least 3 to 5 feet.

Recommend having a qualified contractor install gutters and downspouts at rear and repair front gutters as needed prior to closing.

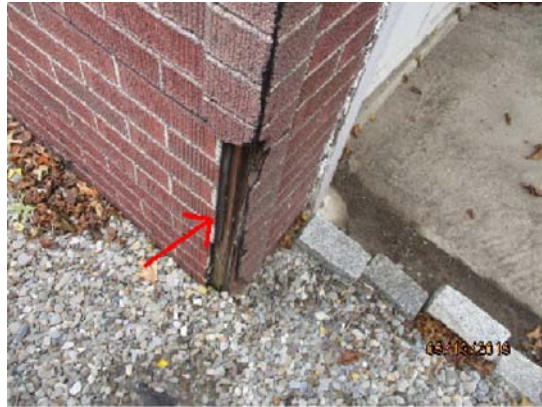
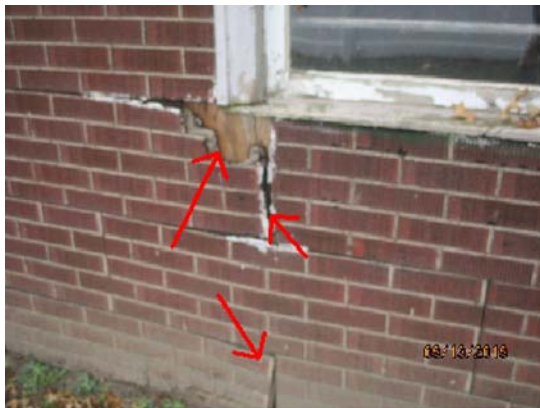
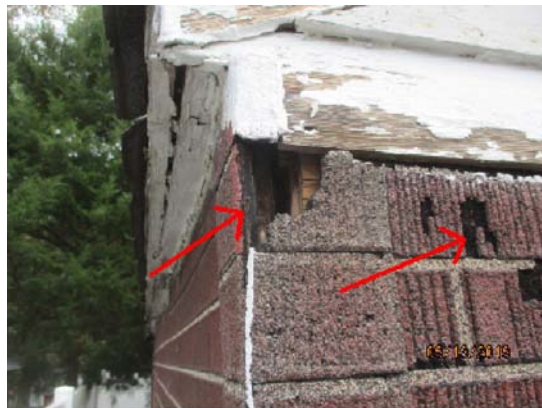
Garage Exterior Walls

Garage exterior siding is asphalt that is loose, has missing siding and lots of holes with exposed wood noted. Front left corner trim is missing and wood is exposed. Left rear corner has a hole and exposed wood noted.

Recommend having a qualified contractor repair as needed to prevent water intrusion prior to closing.

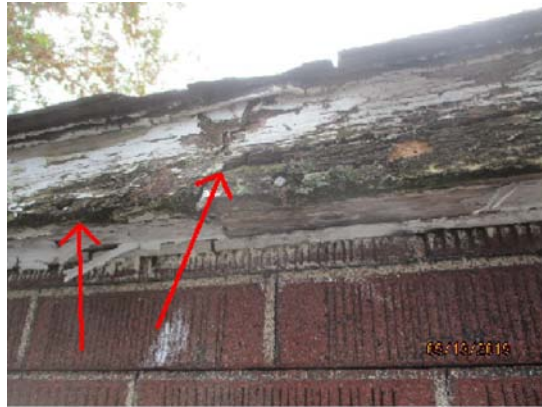
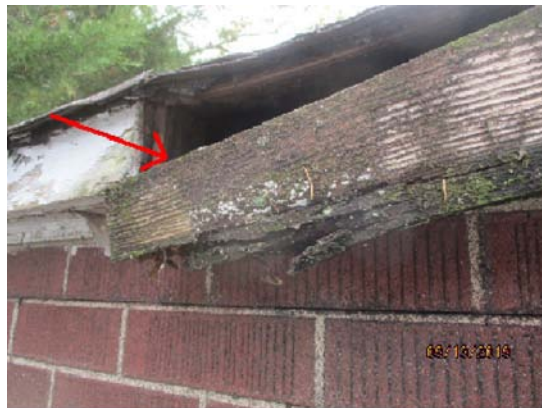
Garage Fascia/Soffit

Rear and front soffits and fascias are rotted and falling off.

Recommend having a qualified contractor repair as needed to prevent water, bird and animal intrusion prior to closing.

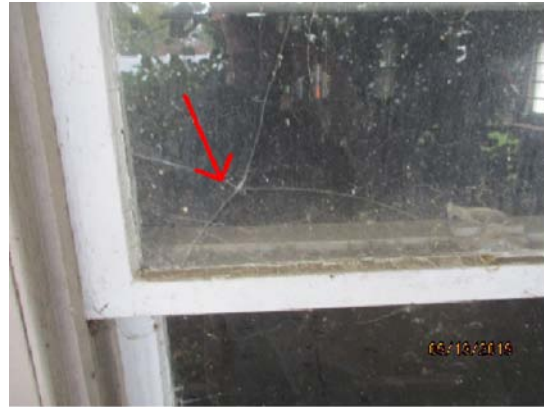
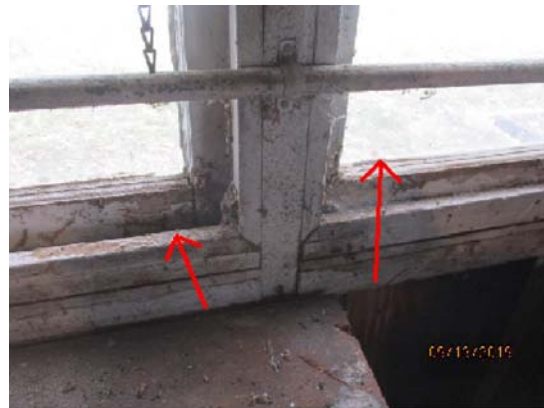
Garage Windows

Garage front window is broken. Right side windows two wont open and one wont close completely.

Recommend having a qualified window contractor repair or replace as needed prior to closing.

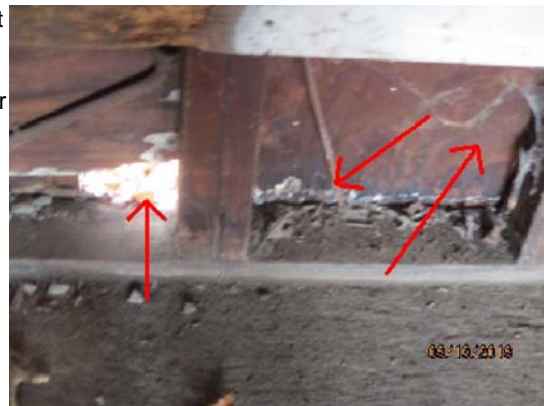
Garage Interior Walls

Large gap and daylight coming threw wall at rear left side. What appears to be mold noted on interior wall in several areas.

Recommend having a qualified contractor evaluate and clean or repair as needed prior to closing.

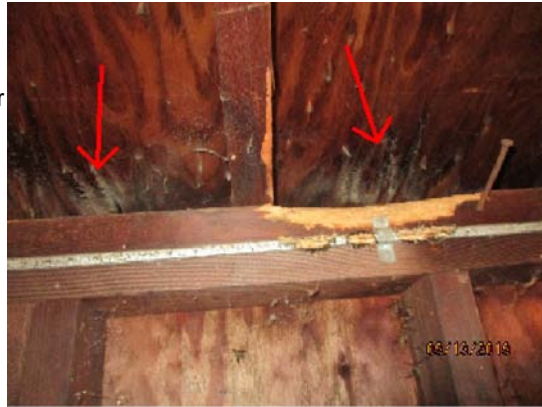
Garage Interior Ceiling

Garage roof sheathing has what appears to be mold noted in several areas.

Recommend having a qualified contractor evaluate and clean or repair as needed prior to closing.

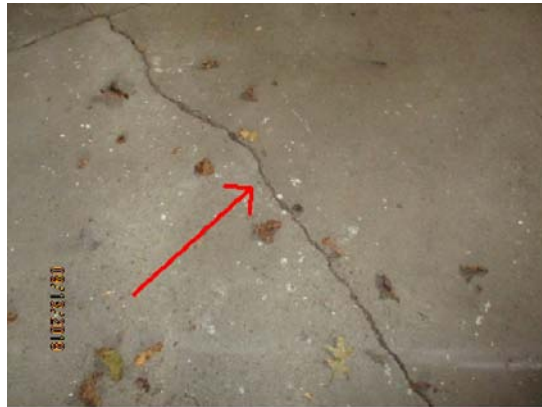
Garage Floor

Cracks noted on garage floor.

Recommend having a qualified contractor seal cracks to prevent water intrusion and trip hazard prior to closing.

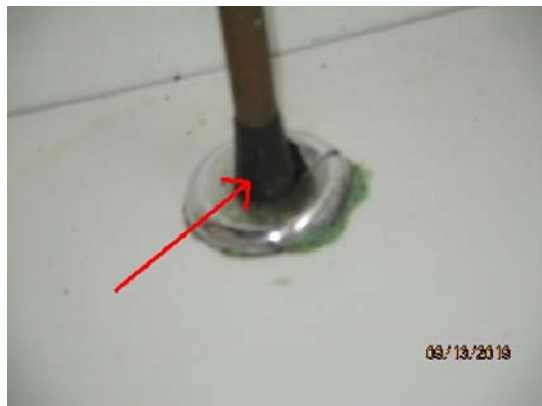
Drain and supply

Improper repair noted on plumbing line under kitchen sink.

Recommend having a licensed plumber evaluate and repair as needed prior to closing.

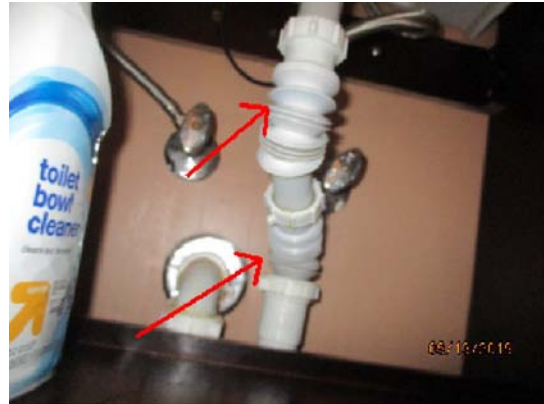
Improper use of flexible drain pipes in first floor bathroom. Flexible drain pipes should only be offset 10 degrees.

Recommend having a licensed plumber repair as needed prior to closing.

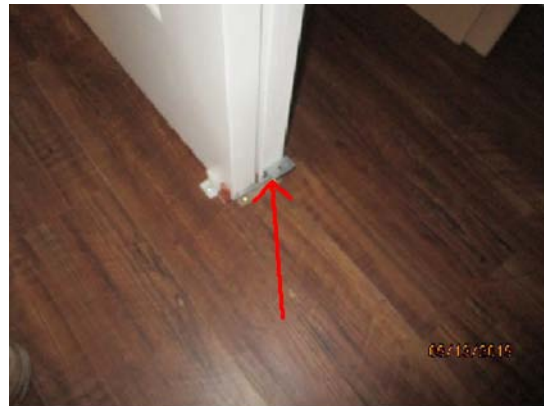
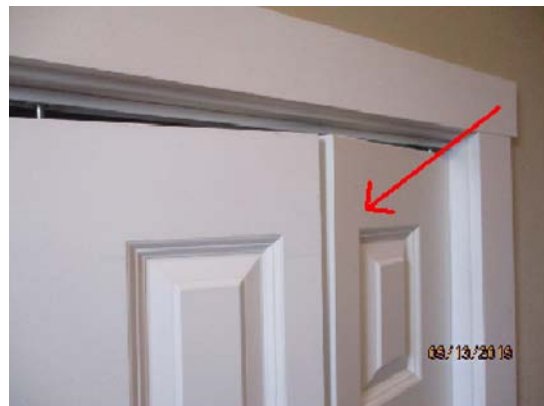
Doors

Right front bedroom the closet doors on right side will not move and have a bracket mounted to the bottom of them. Second floor hallway closet doors wont stay closed.

Recommend having a qualified contractor evaluate and repair as needed prior to closing.

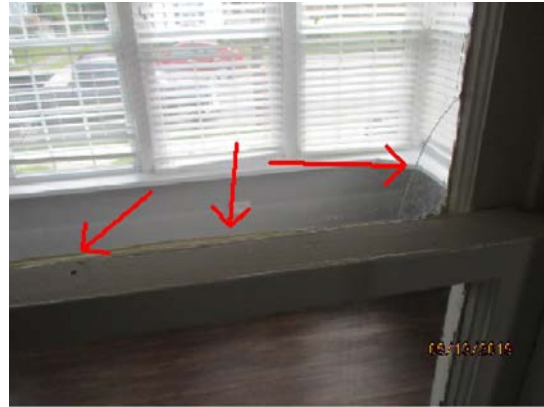
Windows

Living room front window has a cracked pane of glass, no lock and window wont close completely.

Recommend having a qualified window contractor repair or replace as needed prior to closing.

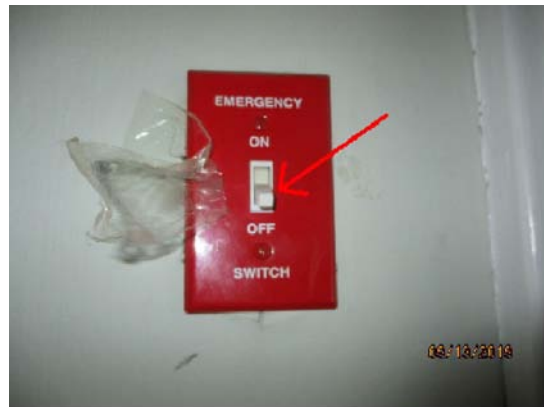
Energy Source

Top of stairs the emergency shut off switch does not work. The one on the furnace does.

Recommend having a licensed electrician evaluate and repair as needed prior to closing.

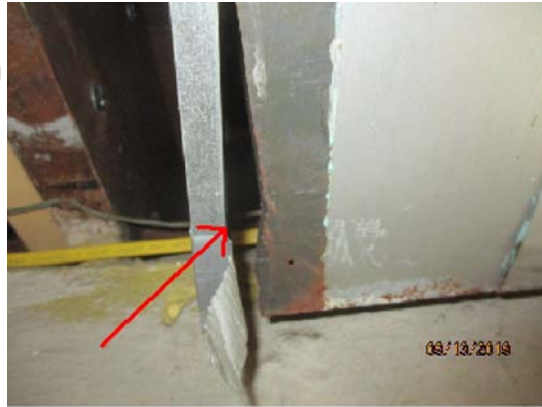
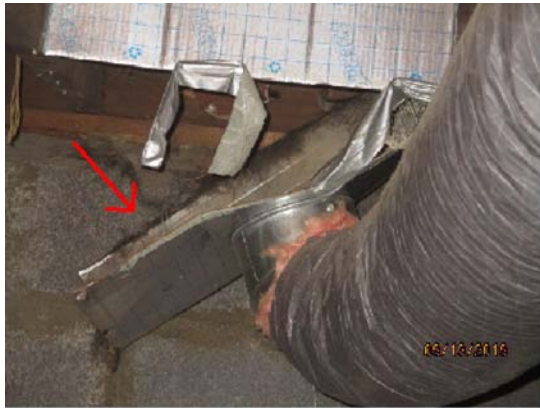
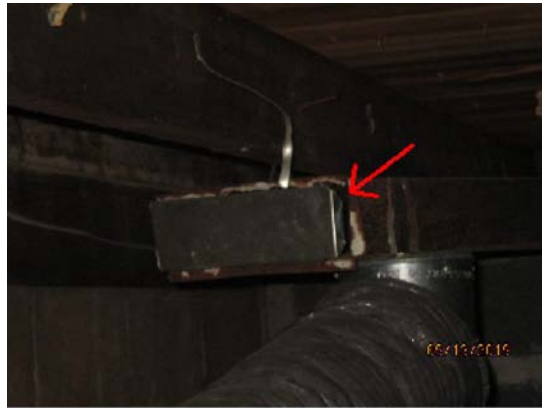
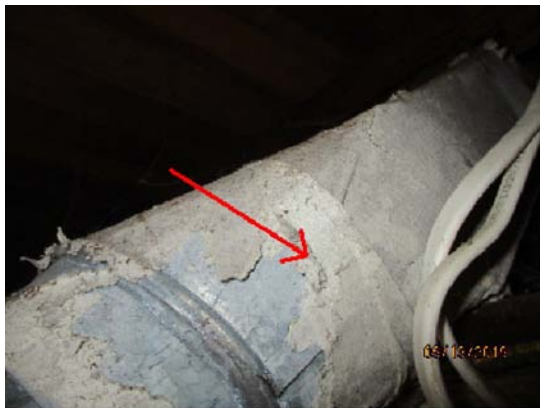
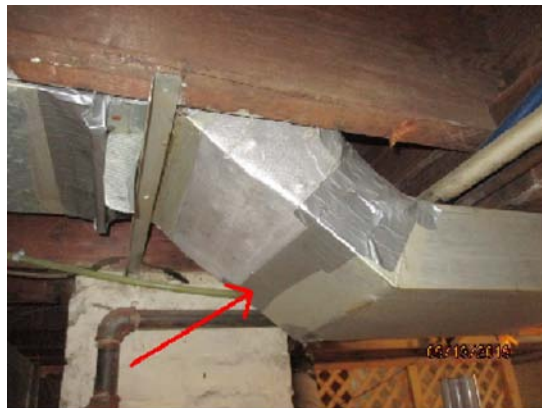
Distribution Material

Basement left side duct the end cap is falling off. Rear crawl space duct end cap is loose and has gaps. Rear crawl space duct for right rear bedroom is disconnected (no heat or a/c going to that room). Regular duct tape noted on duct work joints in basement. This is the wrong type of tape.

Possible asbestos noted on several metal ducts in basement.

Recommend having a licensed HVAC contractor evaluate and repair as needed prior to closing.

Recommend having a qualified contractor evaluate and remove or encapsulate as needed prior to closing.

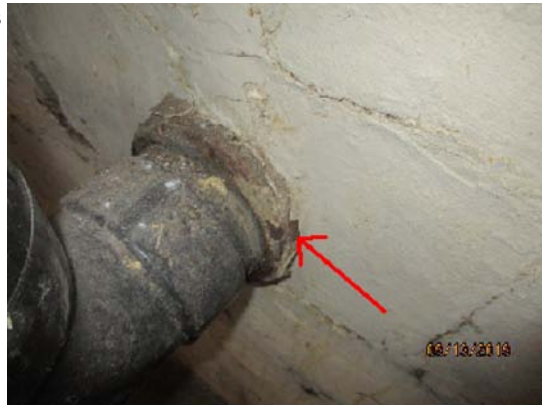
Cast iron waste pipes noted in basement. Cast iron waste pipes are very old and corrode and rusts from the inside.

Recommend budgeting for repairs or replacement of cast iron waste pipes as needed.

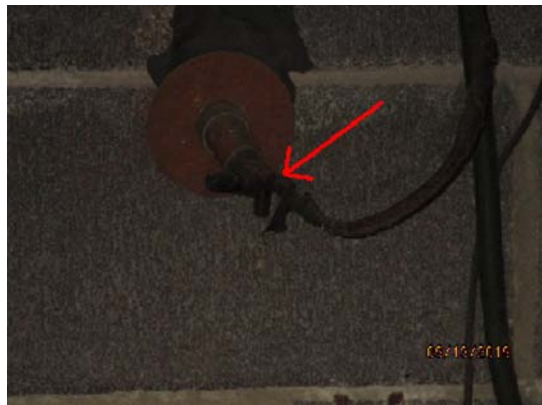
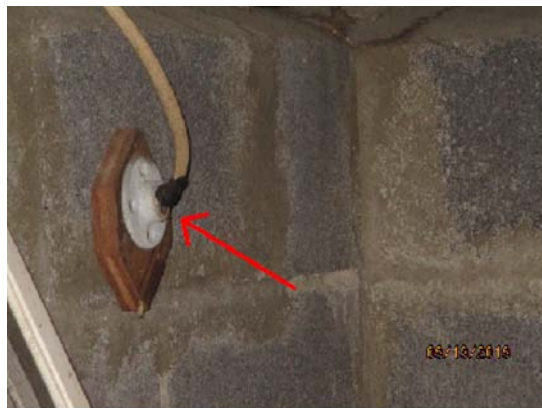
Improperly spliced wire noted in front crawl space. Wire in rear crawl space going through concrete block appears to not be in conduit.

Recommend having a licensed electrician repair as needed prior to closing.

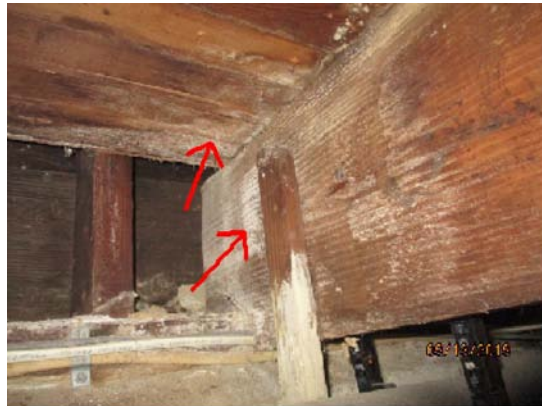
Previous moisture, rotted wood and what appears to be mold noted on sub floor and joists under bathroom. Tested with moisture meter. Dry at time of inspection. It should be understood that it is impossible to predict the severity or frequency of water and moisture penetration on a one time visit.

Recommend having a qualified contractor evaluate and clean or repair as needed prior to closing.

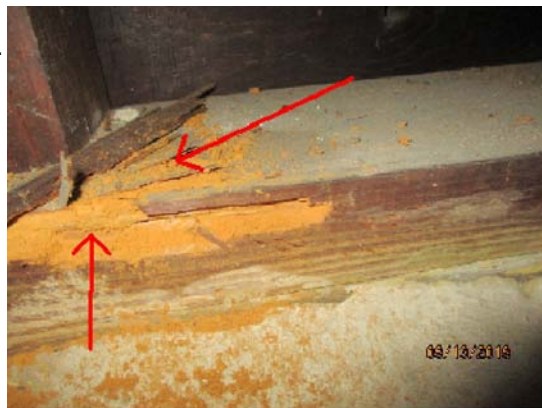
Basement Sill Plate

Termite damage noted on basement rear sill plate. The termite evidence noted does not include hidden damage that may exist. This inspection can not conclude any amount of damage exists inside an area that is not visible to the inspector.

Recommend having a qualified contractor repair the damage and treatment for termites done prior to closing.

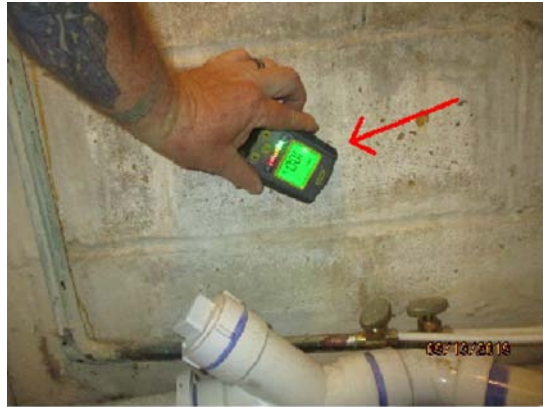
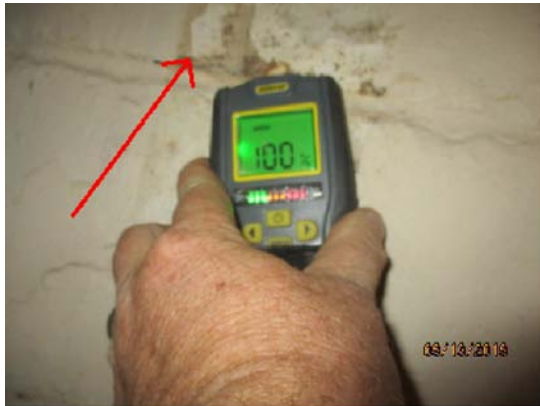
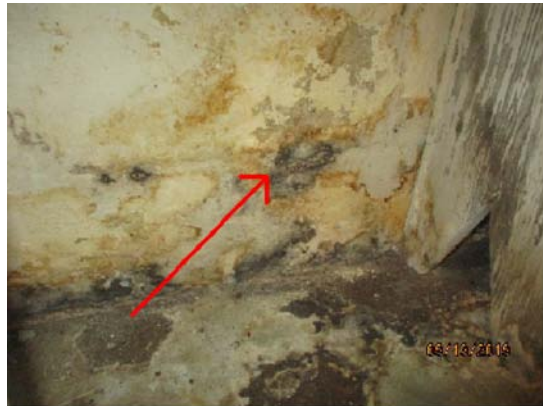
Basement Foundation Walls

The basement foundation walls show evidence of moisture penetration in the form of stains, efflorescence and what appears to be mold. Tested with moisture meter. Up to 100% moisture noted. It should be understood that it is impossible to predict the severity or frequency of water and moisture penetration on a one time visit. Virtually all basements exhibit signs of moisture penetration and virtually all basements will indeed leak at some point and time. Basement leakage rarely affects the structural integrity of a home.

Recommend having a qualified water proofing contractor evaluate and clean or repair possible mold and make any further recommendations prior to closing.

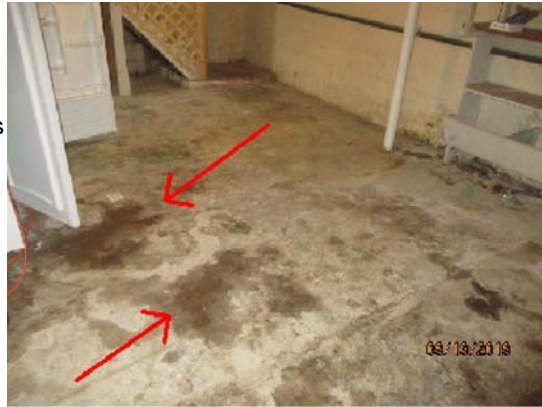
Basement Floor

The basement floor shows evidence of moisture penetration in the form of water and moisture. Tested with moisture meter. Up to 100% moisture noted. It should be understood that it is impossible to predict the severity or frequency of water and moisture penetration on a one time visit. Virtually all basements exhibit signs of moisture penetration and virtually all basements will indeed leak at some point and time. Basement leakage rarely affects the structural integrity of a home.

Recommend having a qualified water proofing contractor evaluate and make any further recommendations prior to closing.

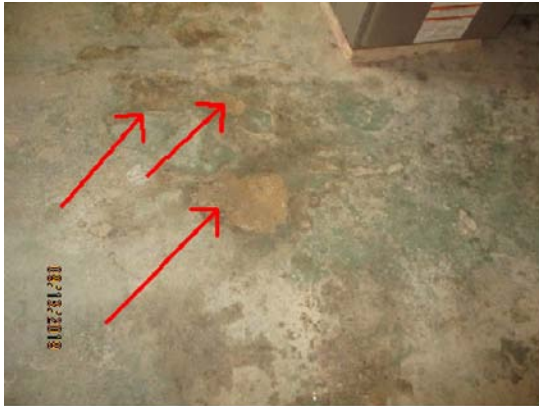
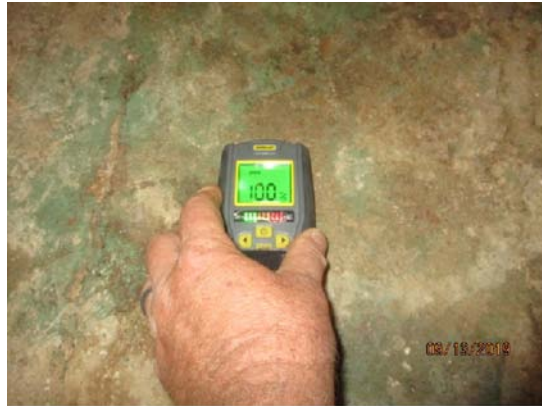
Spalling noted on basement floor in several areas.

Recommend having a qualified contractor repair as needed prior to closing.

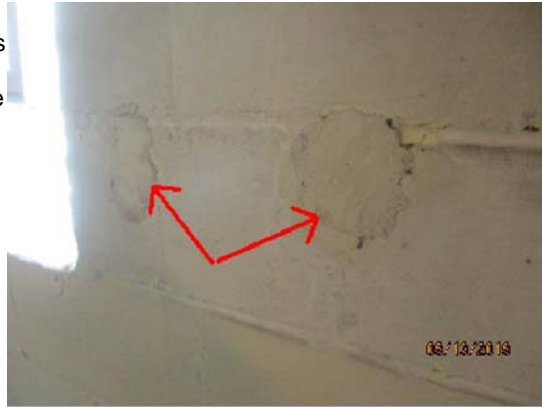
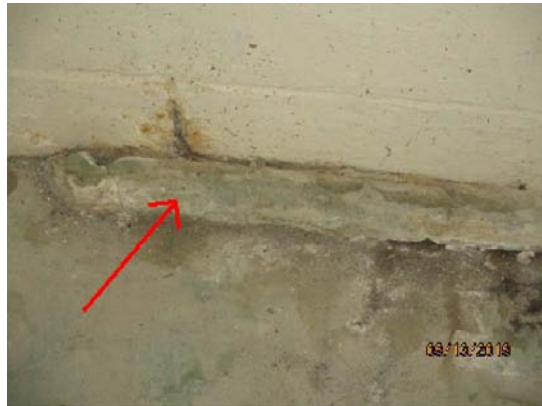
Miscellaneous 1

We do not inspect for underground oil tanks. There is evidence to suggest the possibility of an underground storage tank on this property. Patched holes in concrete block near concrete on left side at floor. Leaking oil tanks can be very expensive to mitigate and require special licensing from the DEP.

Recommend having a qualified contractor scan the property for a tank prior to closing.

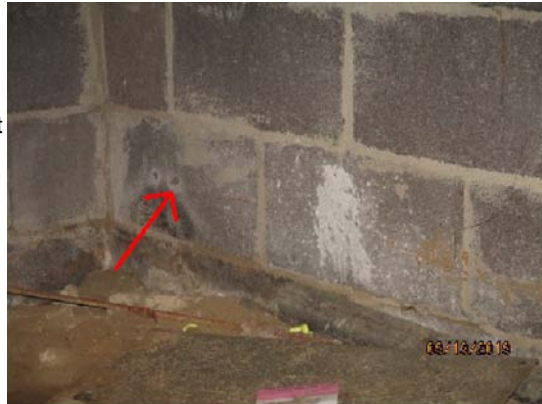
Crawl Space Foundation Walls

The crawl space foundation walls show evidence of moisture penetration in the form of efflorescence. Appears to be dry at time of inspection. It should be understood that it is impossible to predict the severity or frequency of water and moisture penetration on a one time visit. Virtually all crawl spaces exhibit signs of moisture penetration and virtually all crawl spaces will indeed leak at some point and time. Crawl space leakage rarely affects the structural integrity of a home.

Recommend having a qualified water proofing contractor evaluate and make any further recommendations prior to closing.

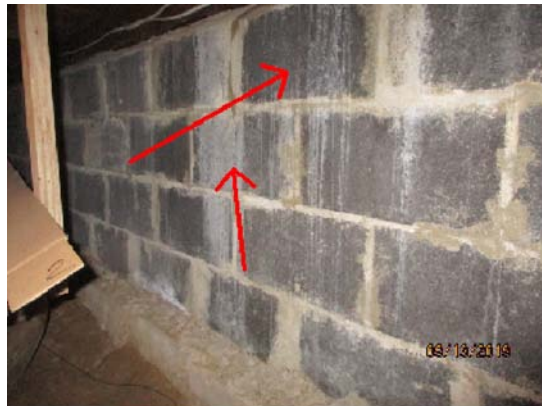
Vertical crack noted on foundation wall in rear crawl space. No deflection. The crack appears to be static and does not threaten the integrity of the structure.

Recommend having a qualified contractor repair as needed to prevent water intrusion prior to closing. Then monitor.

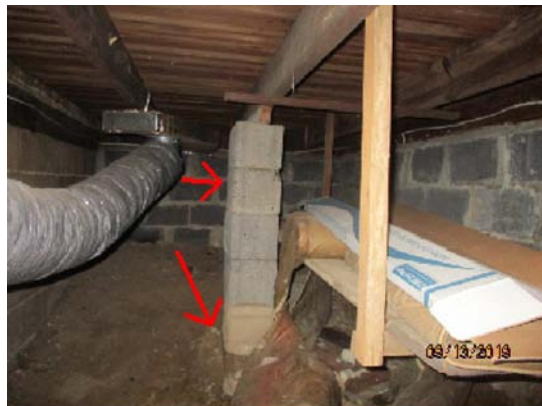
Crawl Space Structural Columns

Temporary concrete block columns that appear to not have footings noted in rear crawl space.

Recommend having a qualified contractor install permanent columns as needed prior to closing.

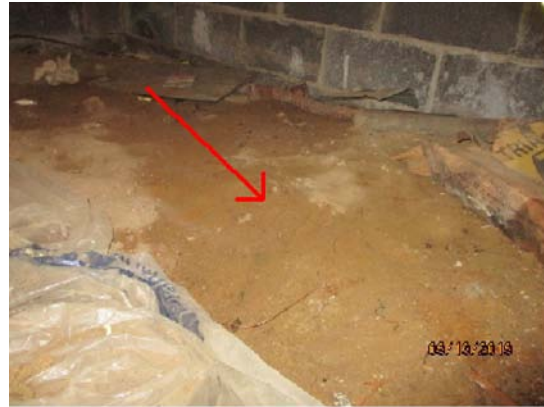
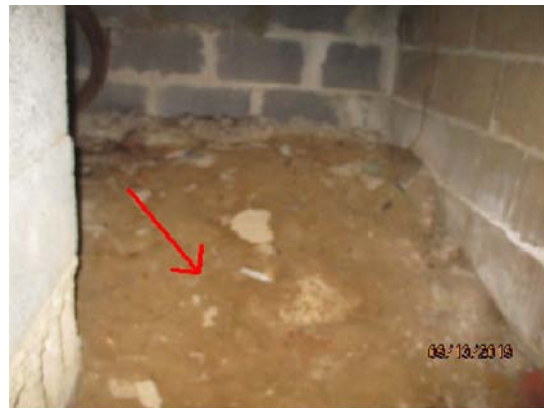
Crawl Space Floor Type

The crawl space dirt floors show evidence of moisture penetration in the form of being damp. It should be understood that it is impossible to predict the severity or frequency of water and moisture penetration on a one time visit. Virtually all crawl spaces exhibit signs of moisture penetration and virtually all crawl spaces will indeed leak at some point and time. Crawl space leakage rarely affects the structural integrity of a home.

Recommend having a qualified water proofing contractor evaluate and make any further recommendations prior to closing.

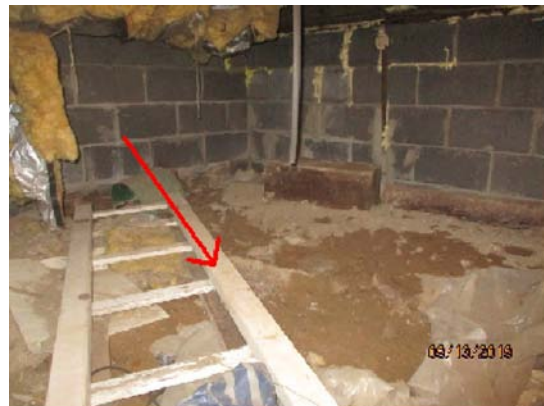
Crawl Space Vapor Barrier

No vapor barrier present in both crawl spaces.

Recommend having a qualified contractor repair as needed prior to closing.

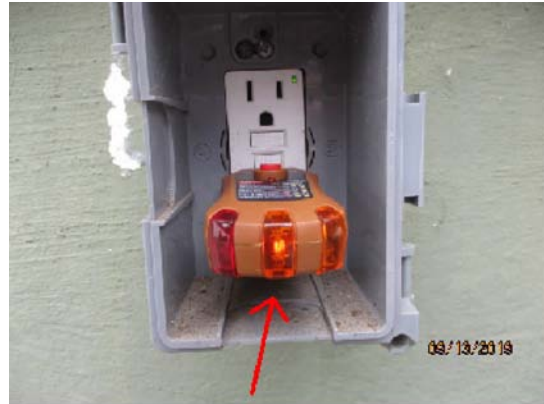
Rear exterior outlet is GFCI protected and it has an open ground and will not work properly. This is a safety concern.

Recommend having a licensed electrician repair as needed prior to closing.

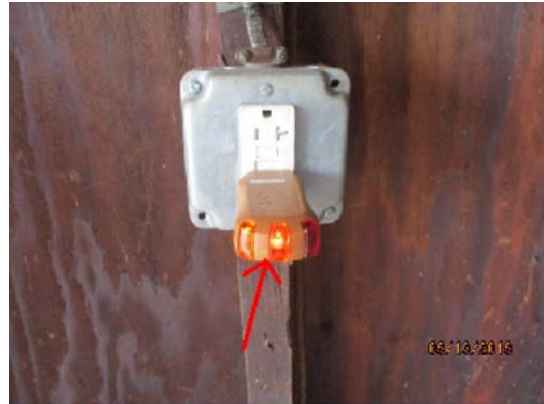
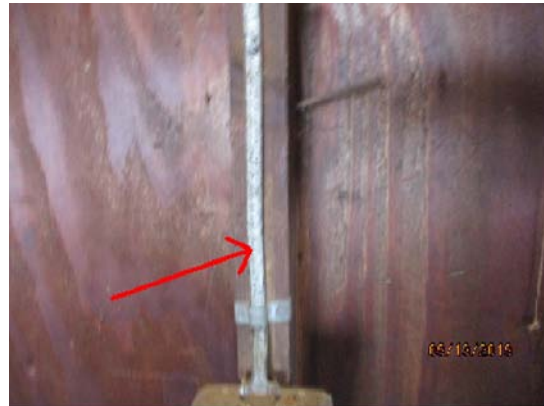
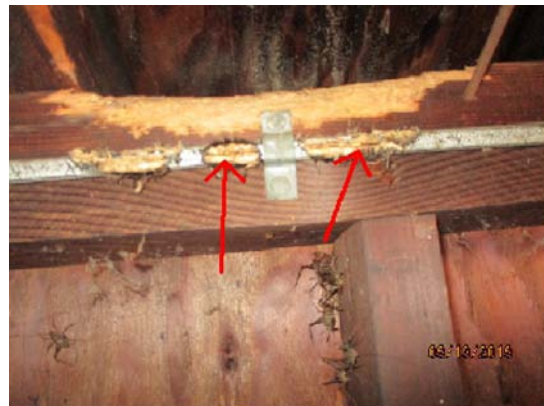
Low wires noted in garage. Wires below six feet should be in conduit.

Improperly spliced wire and wire sheathing that has been chewed away noted at rear left side.

Exposed fuse noted in garage. It should be in an fuse box.

Recommend having a licensed electrician repair as needed prior to closing.

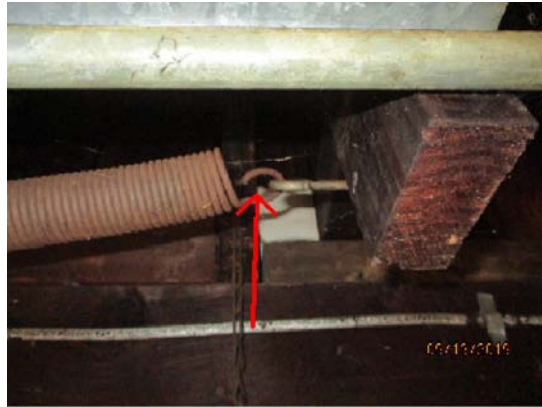
Auto Garage Door Lift Controls

Missing anti coil cable going threwh the springs to prevent re coil of garage door springs. This is a safety concern.

Recommend having a qualified garage door contractor install cable prior to closing.

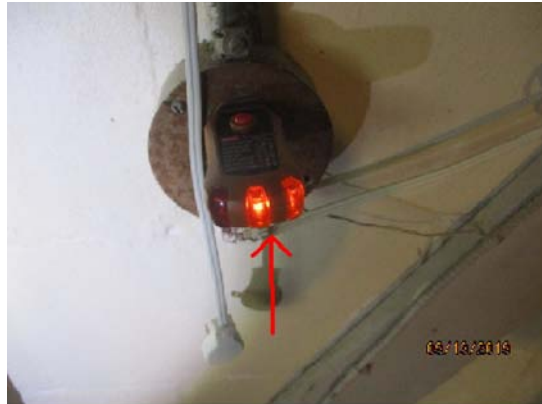
Basement outlet is not GFCI protected. For safety we recommend installing GFCI outlets at all basement outlets.

Recommend having a licensed electrician repair as needed prior to closing.

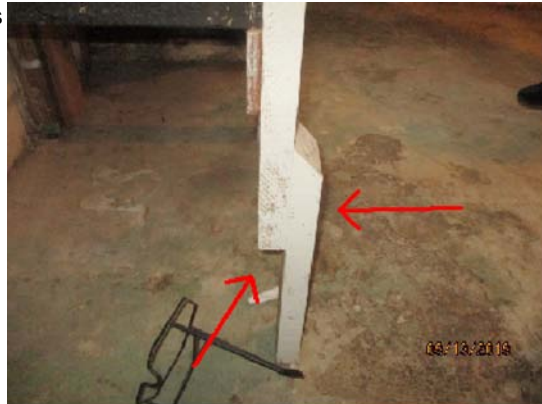
Basement Stairs

Improper support noted in basement for step landing. It appears it was cut and not properly resupported. This is a safety concern.

Recommend having a qualified contractor repair as needed prior to closing.

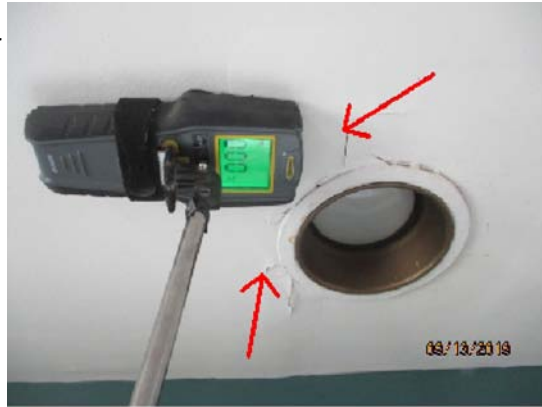
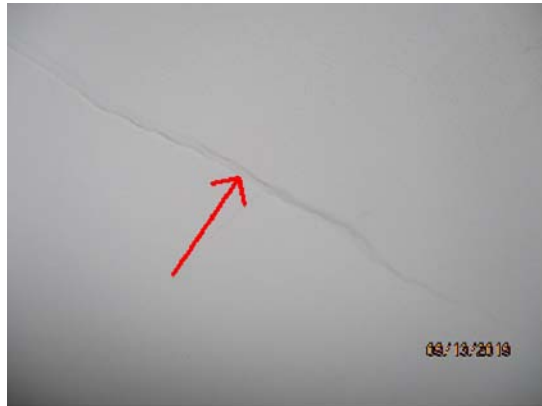
Drywall tape showing in kitchen on ceiling. Cracks and repairs noted on several ceilings throughout the house. Tested with moisture meter. Dry at time of inspection. It should be understood that it is impossible to predict the severity or frequency of water and moisture penetration on a one time visit.

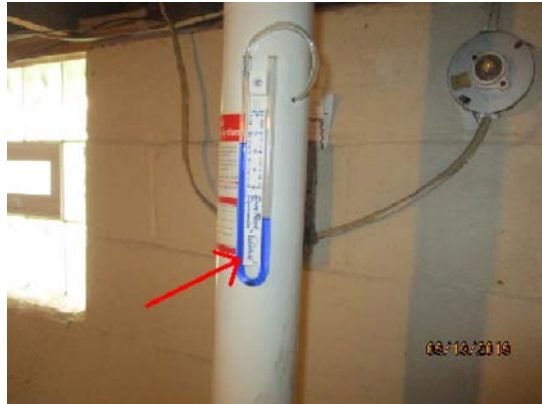
There is a sub slab suction system manometer present in the basement that appears to be in use for the removal of radon gas. Please check with the owner for details as to its operation.
