Sample Home Inspection

Inspected By:
Sample Inspector

Client Information: Record Number 3301

Smith, Joe
1 Main St
Your town, NJ 00000

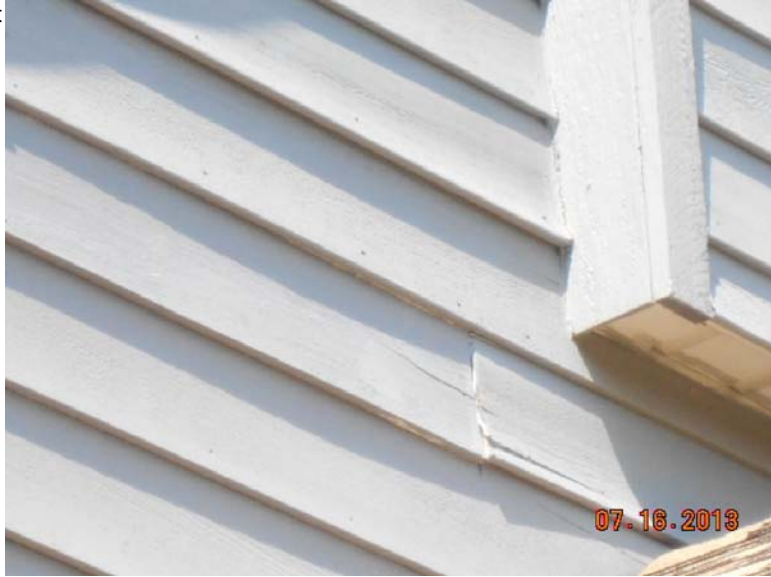
Split clapboards and missing piece on the right side over the garage. Repairs needed.

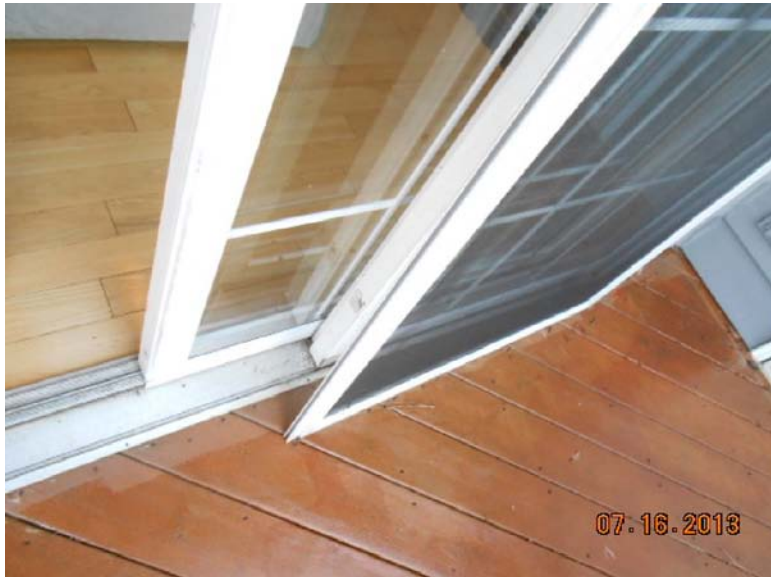
The rear sliding screen door is off track.

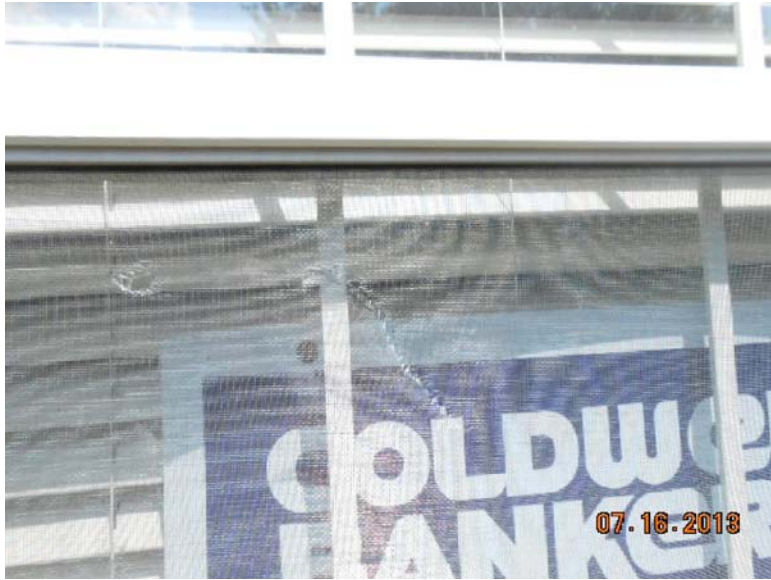
Holes in screens noted.

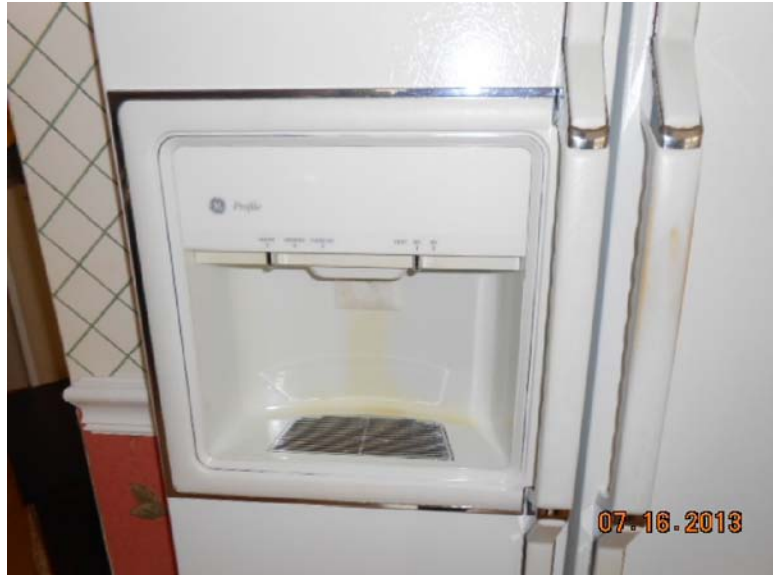
Water dispenser is not operating.

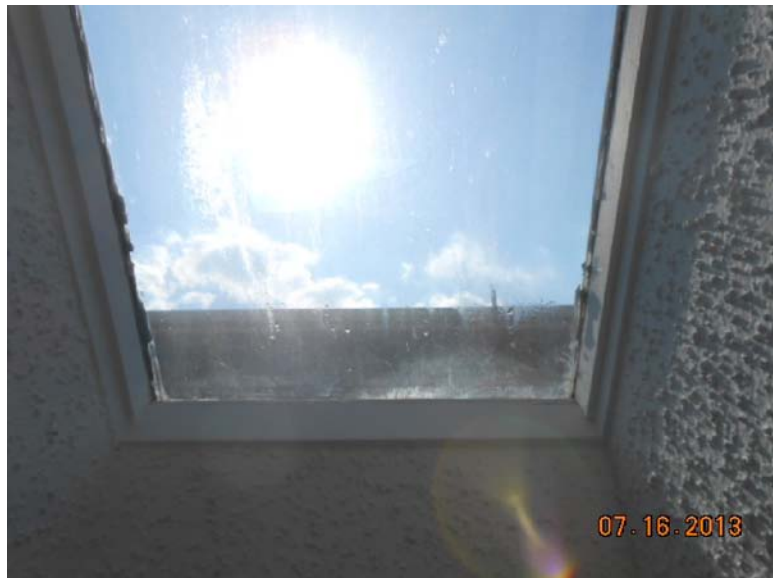
Seals broken in master bath skylight.

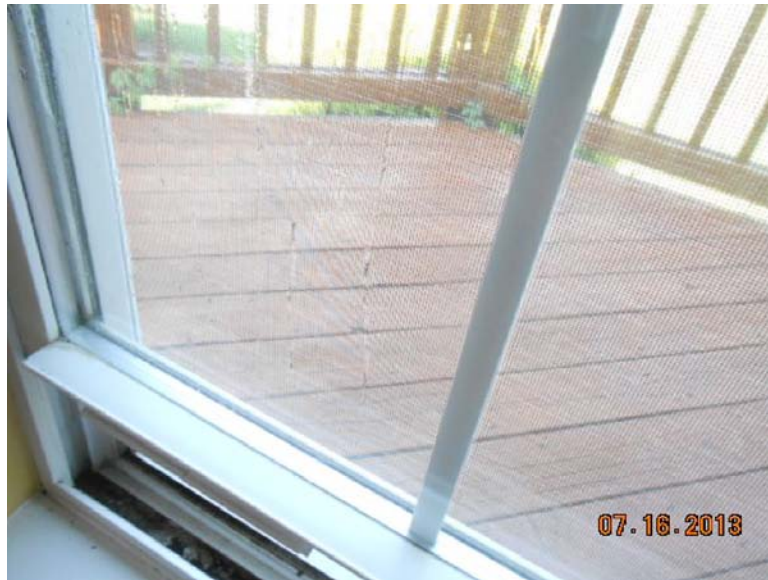
Condensation noted between insulated window panes. 1st floor. 2 occurrences.

2nd floor, 2 occurrences. Bathroom and stairwell.

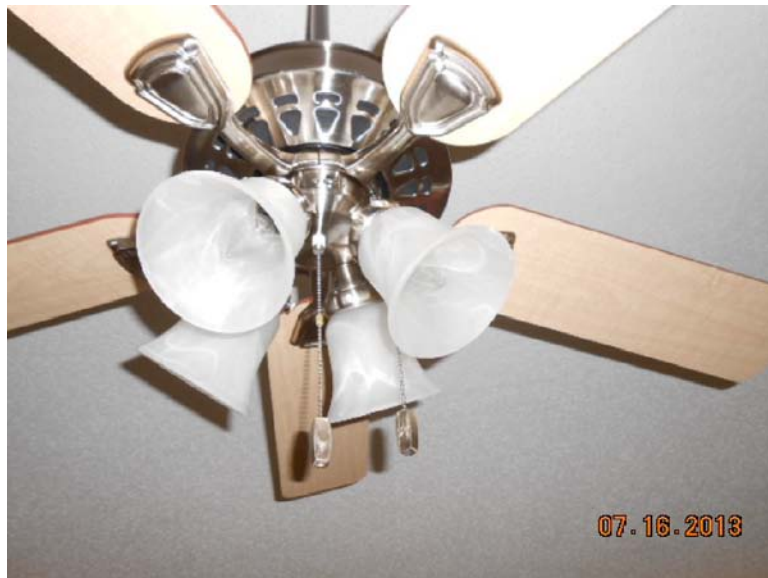
Some of the light fixtures could not be tested due to blown bulbs. Master bedroom, I recommend replacing the bulbs and testing the light fixtures for proper operation once before closing.

Some control knobs missing.

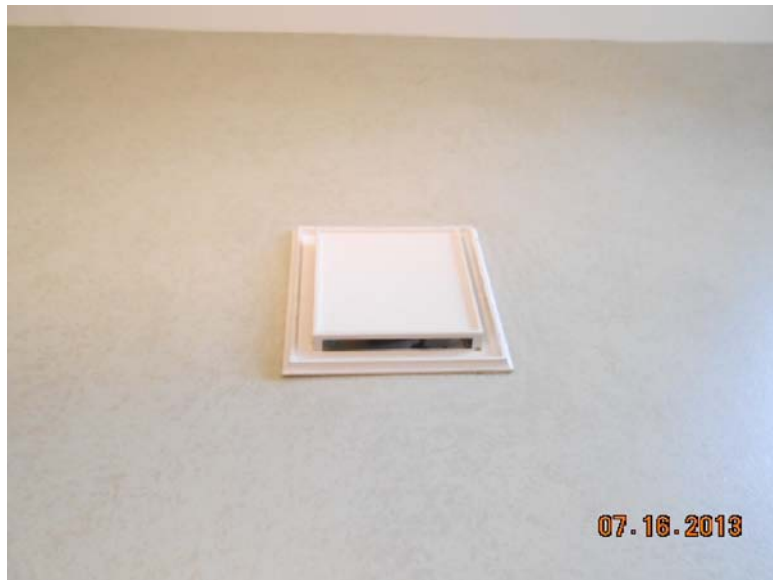
Fan noisy

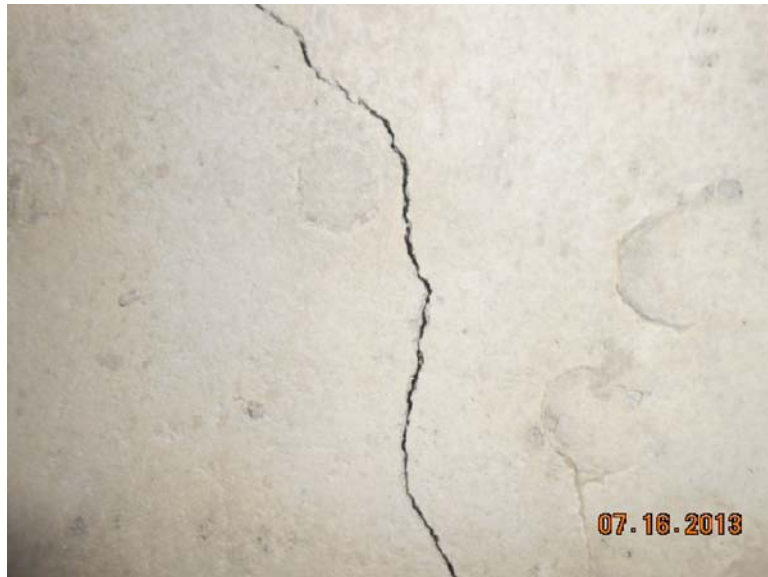
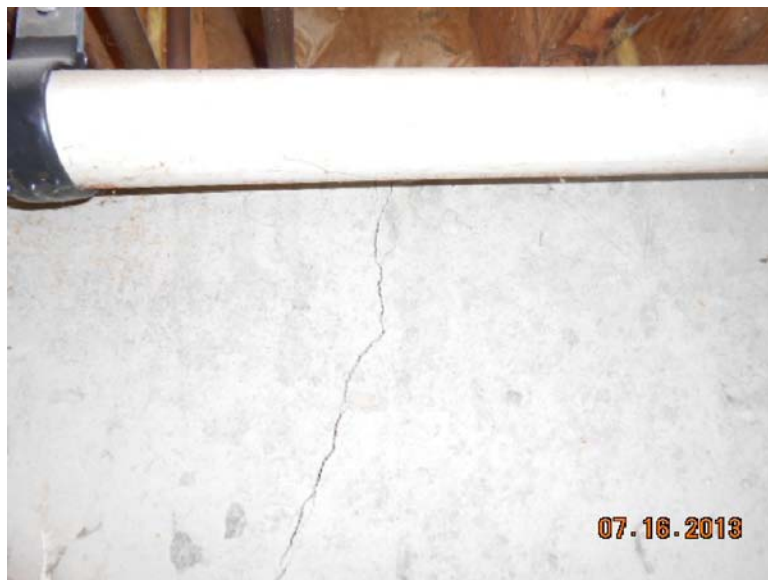
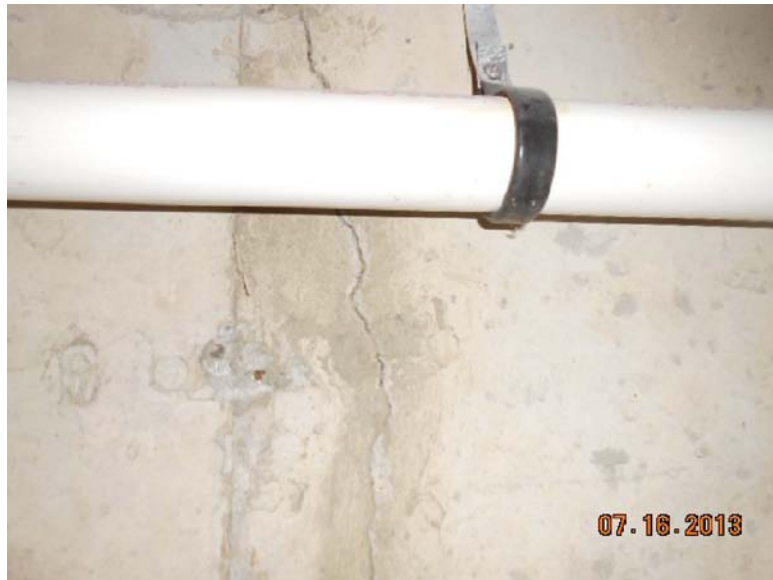
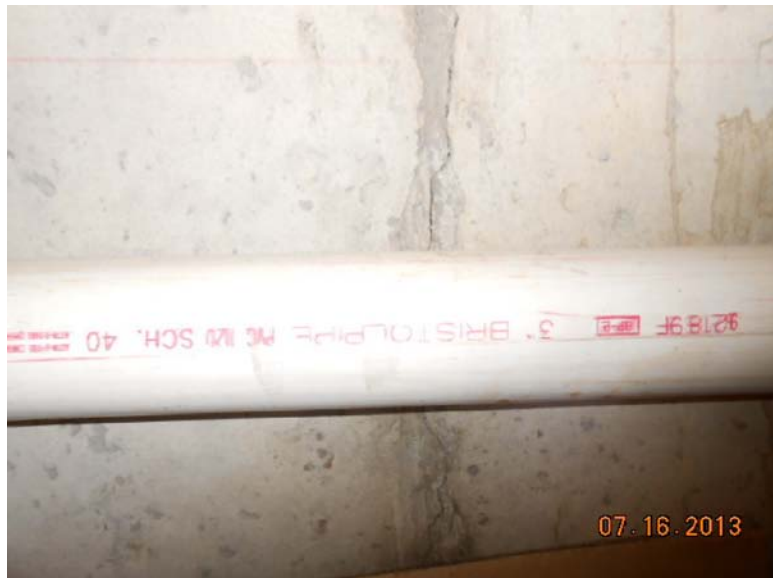
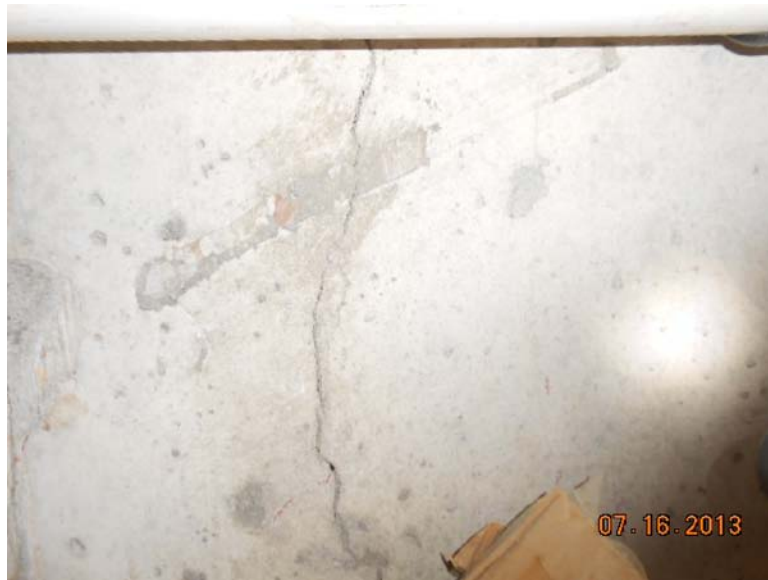
Vertical cracks noted at the front, sides and rear basement wall sections. Approximately 6 cracks. Have the cracks sealed with an epoxy type material by a qualified contractor.

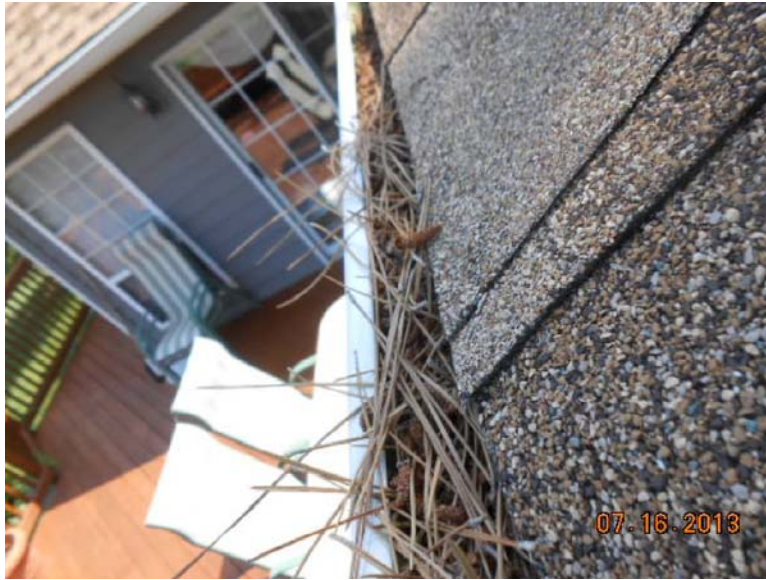
Gutters should be cleaned in the spring and fall.
Clean gutters of debris.

Gutters should be cleaned in the spring and fall.

Clean gutters of debris.

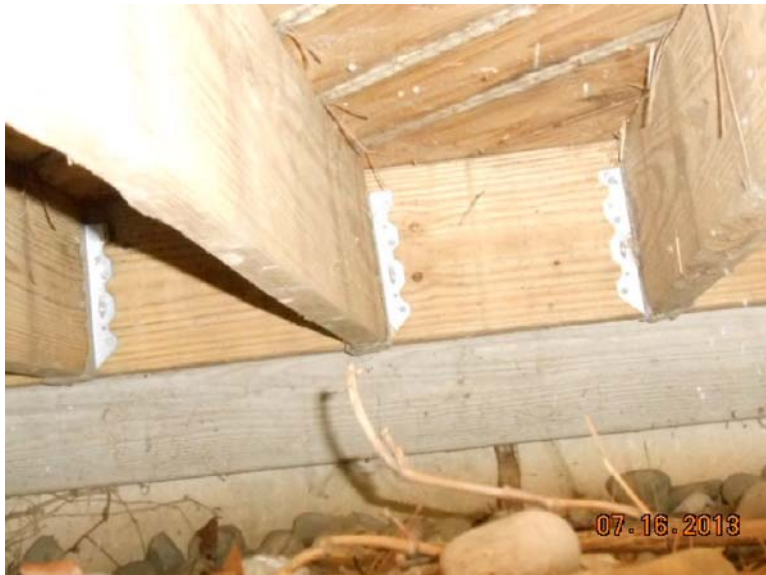
There are no visible lag bolts in the decking header. Lag bolts ensure the integrity of the attachment to a header.

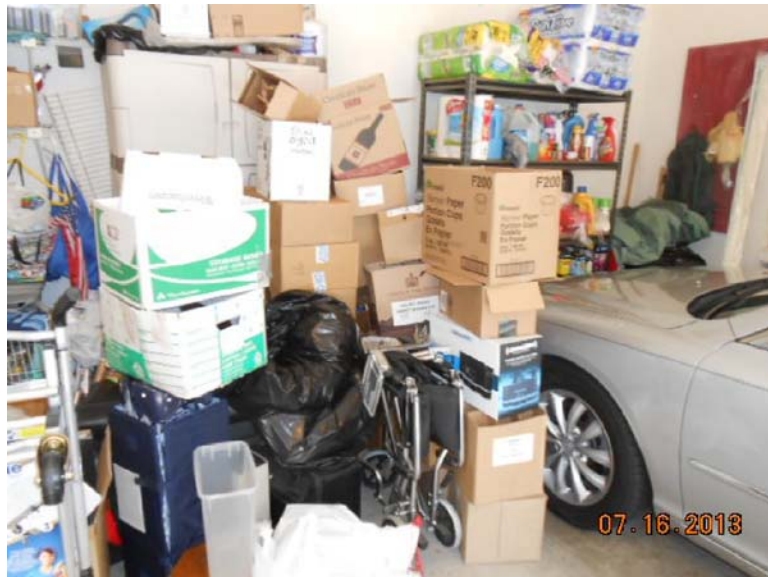
Extensive storage was noted around the perimeter of the garage.

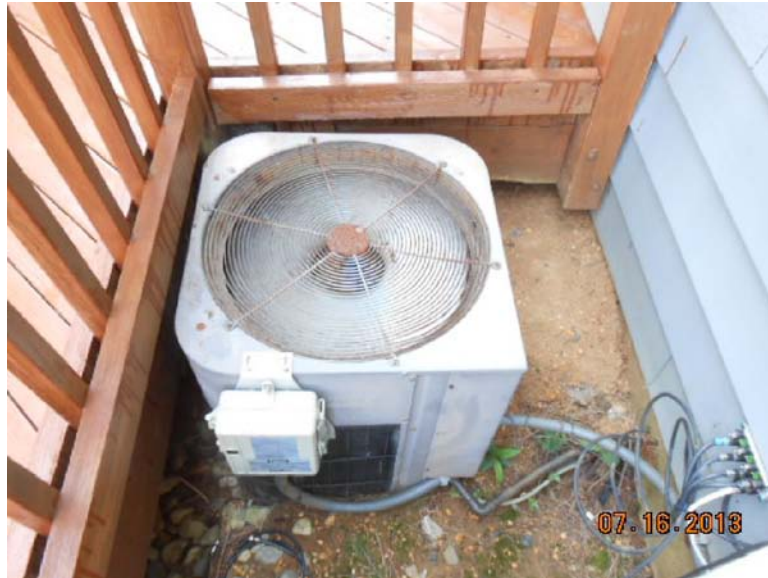
Unit is older and extended life should not be expected without repairs and maintenance.
