Eastern Home Inspections of NJ
3070 Route 206
Columbus, NJ 08022
609-291-1300

Client Information: Record Number E041019b

Inspected 4/10/19 9:00 AM

Inspection Summary

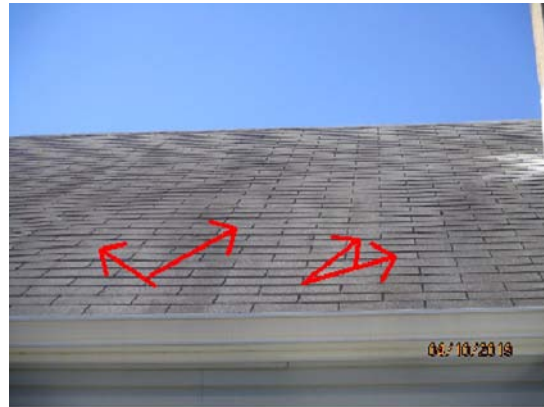
Several lifted shingles noted.

Recommend having a qualified roofing contractor repair as needed prior to closing

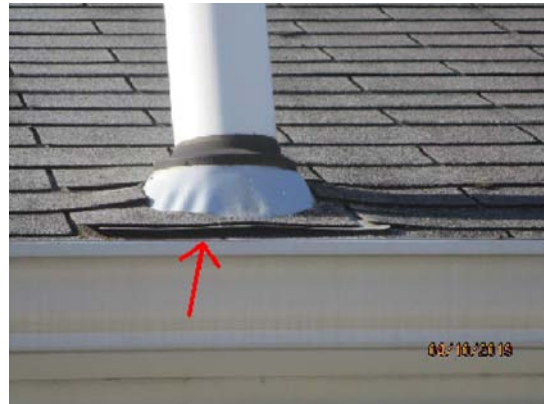
Flashing

Vent pipe flashing is lifting.

Recommend having a qualified roofing contractor repair or replace as needed to prevent water intrusion prior to closing.

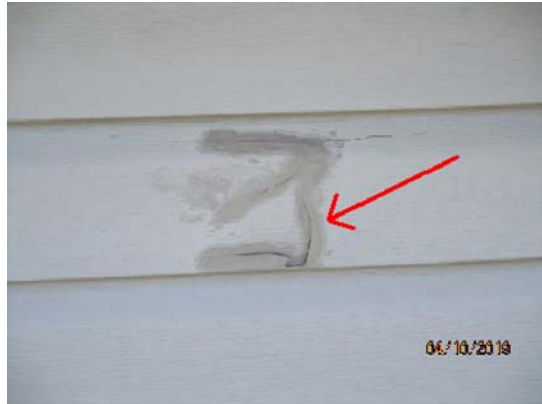
Crack noted on siding at front middle.

Recommend having a qualified contractor repair as needed to prevent water intrusion prior to closing.

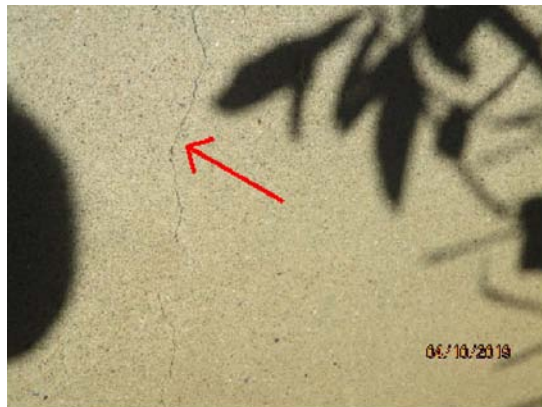
Exposed Foundation

Crack noted on the exposed foundation parging on right side. No deflection. The crack appears to be static and does not threaten the integrity of the structure.

Recommend having a qualified contractor seal crack to prevent water intrusion prior to closing.

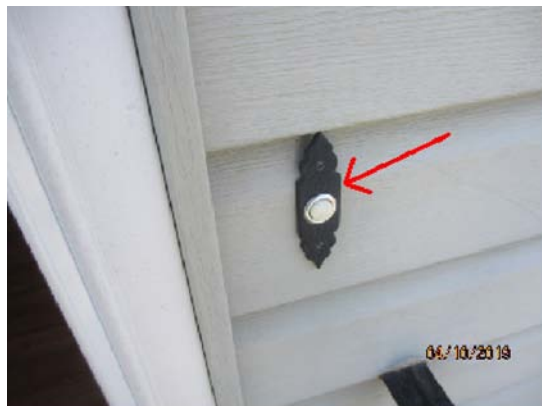
Miscellaneous 1

Rear door bell is not working.

Recommend having a qualified contractor repair as needed prior to closing.

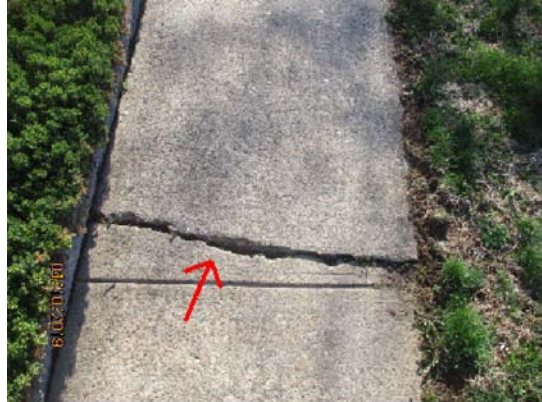
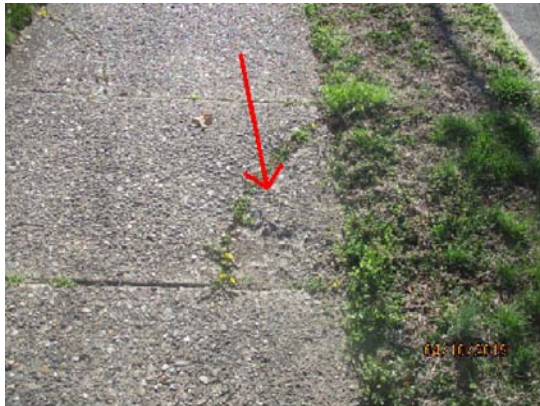
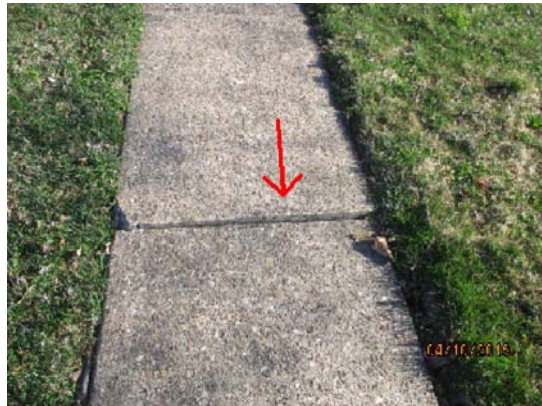
Several cracks, trip hazards and spalling noted on front walks.

Recommend having a qualified contractor repair trip hazards, spalling and seal cracks to prevent trip hazards and water intrusion prior to closing.

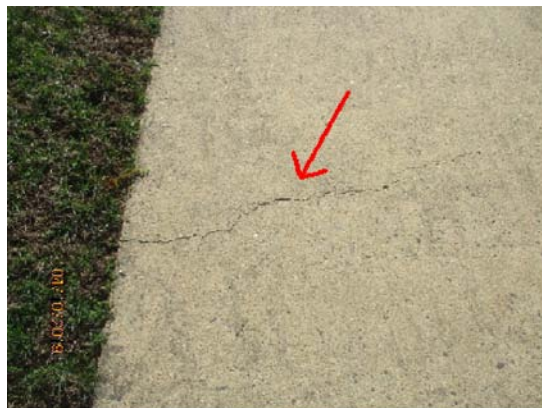
Patio

Crack noted on rear patio.

Recommend having a qualified contractor seal crack to prevent trip hazard and water penetration prior to closing.

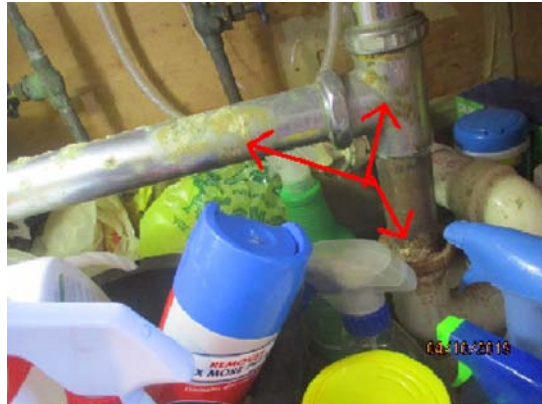
Rust and corrosion noted on drain pipes in kitchen.

Recommend having a licensed plumber repair as needed prior to closing.

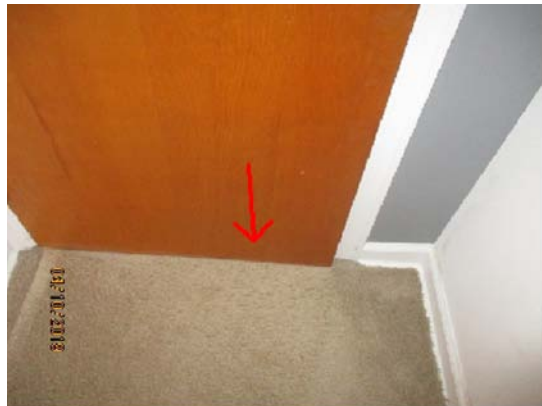
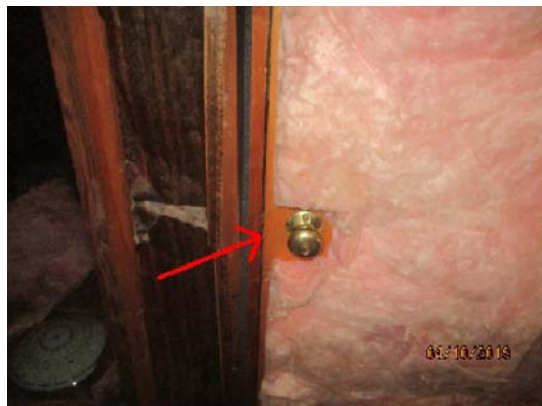
Doors

Second floor bedroom door rubs the floor and will not close completely. Attic door will not latch closed.

Recommend having a qualified contractor repair as needed prior to closing.

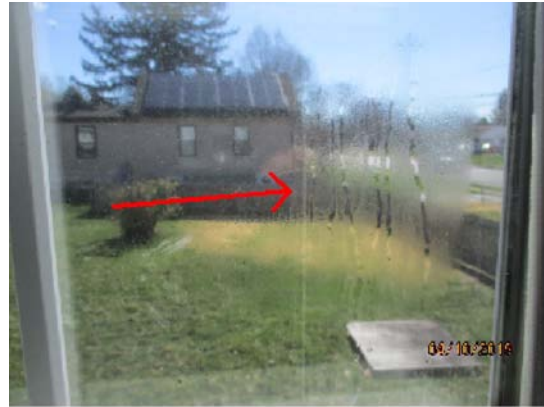
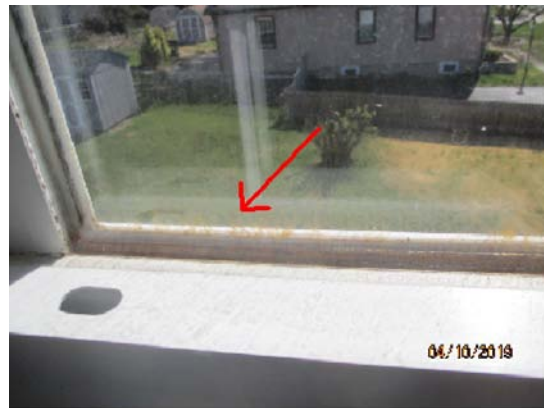
Windows

First floor right front bedroom side window seal is broken.
Second floor bedroom both window seals are broken.

Recommend having a qualified window contractor repair as needed prior to closing.

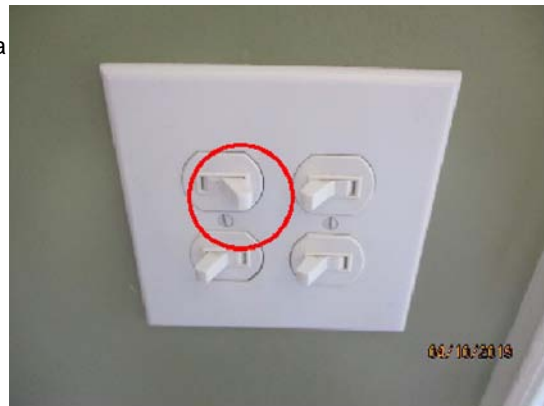
Interior Switches

One switch by back door has unknown operation. Try asking the owner what it operates. If unknown we recommend having a licensed electrician evaluate and repair as needed prior to closing.

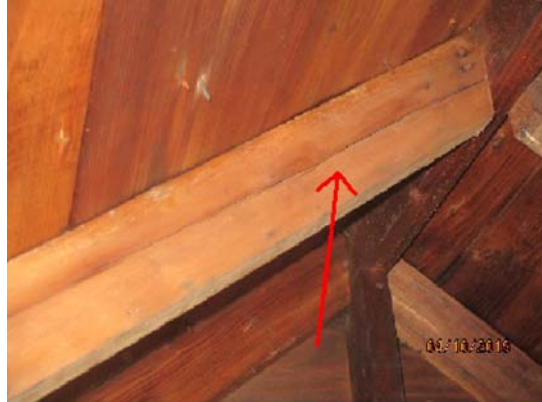
Split rafter noted at left side front dormer area.

Recommend having a qualified contractor repair as needed prior to closing.

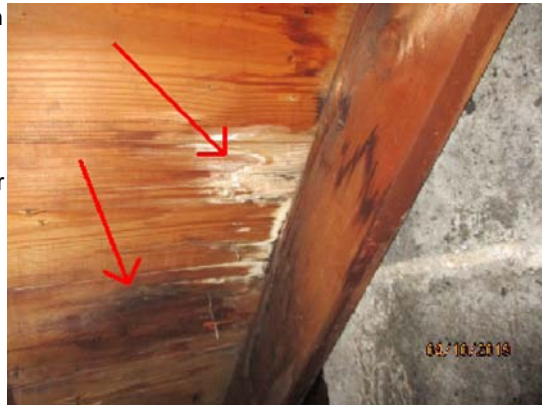
Attic Sheathing

Previous moisture stains and what appears to be mold noted on roof sheathing. Tested with moisture meter. Dry at time of inspection. It should be understood that it is impossible to predict the severity or frequency of water and moisture penetration on a one time visit.

Recommend having a qualified contractor evaluate and clean or repair as needed prior to closing.

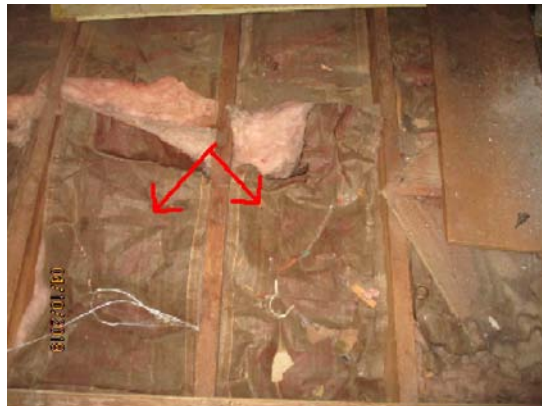
Attic Insulation Thickness

Insulation in attic is less than 6".

Recommend having a qualified contractor add at least 6" of insulation prior to closing.

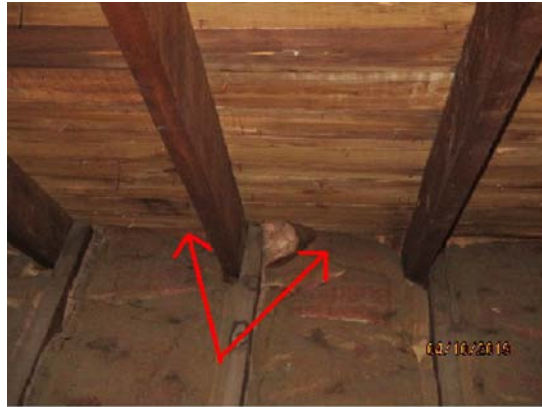
Attic Ventilation

Some soffits are blocked with insulation. Baffles are needed so soffits have proper air flow.

Recommend having a qualified contractor install baffles as needed prior to closing.

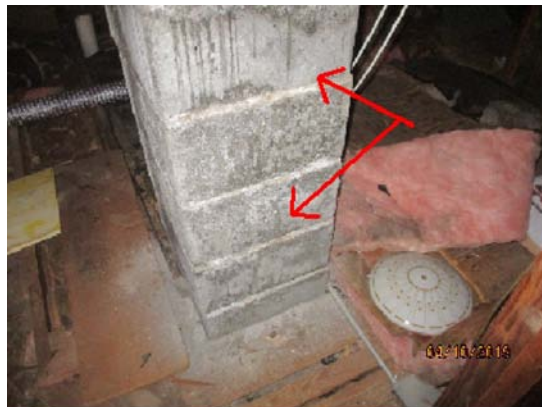
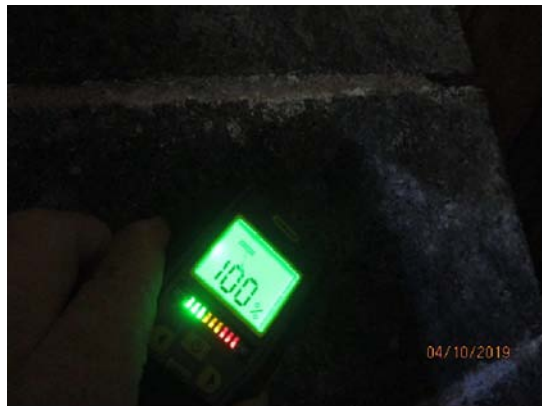
Attic Chimney Flues

The chimney in the attic shows evidence of moisture penetration in the form of stains and efflorescence. Tested with moisture meter. Up to 100% moisture noted. It should be understood that it is impossible to predict the severity or frequency of water and moisture penetration on a one time visit.

Recommend having a qualified contractor evaluate and repair as needed prior to closing.

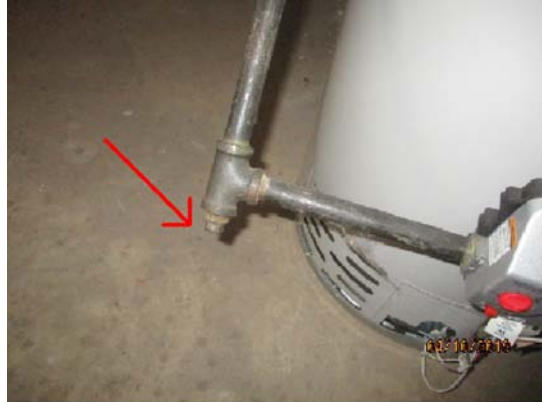
Drip leg missing on supply gas line.

Recommend having a licensed plumber repair as needed prior to closing.

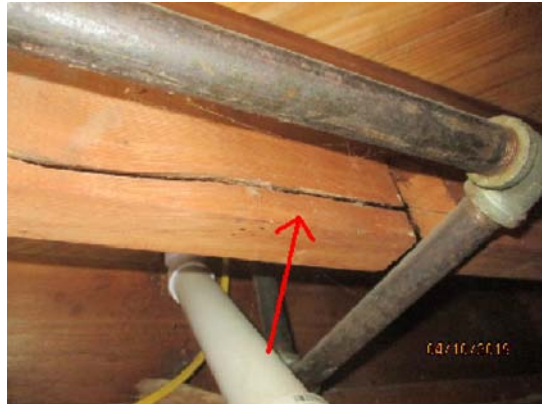
Basement Ceiling Joists

Split joist noted at left side rear.

Recommend having a qualified contractor repair as needed prior to closing.

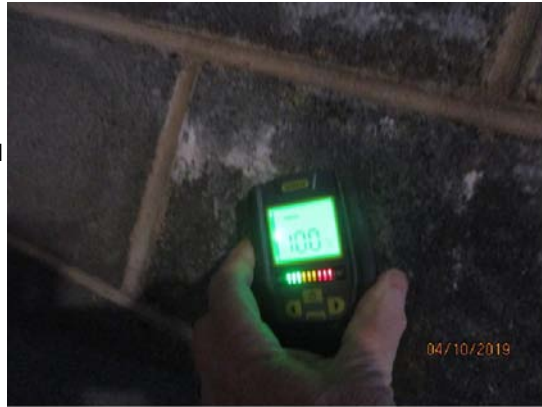
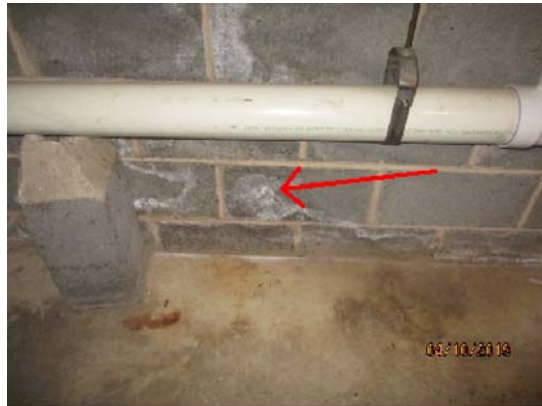
Basement Foundation Walls

The basement foundation walls show evidence of moisture penetration in the form of stains and efflorescence. Tested with moisture meter. Up to 100% moisture noted. It should be understood that it is impossible to predict the severity or frequency of water and moisture penetration on a one time visit. Virtually all basements exhibit signs of moisture penetration and virtually all basements will indeed leak at some point and time. Basement leakage rarely affects the structural integrity of a home.

Recommend having a qualified water proofing contractor evaluate and make any further recommendations prior to closing.

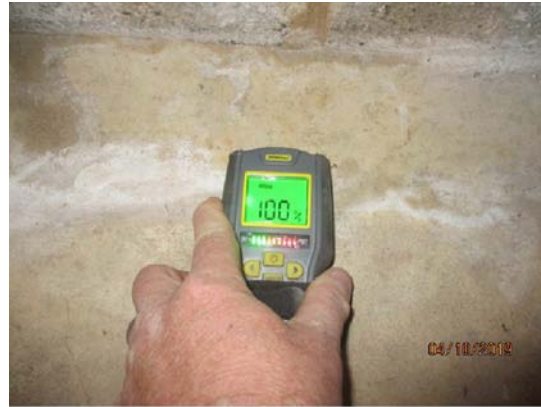
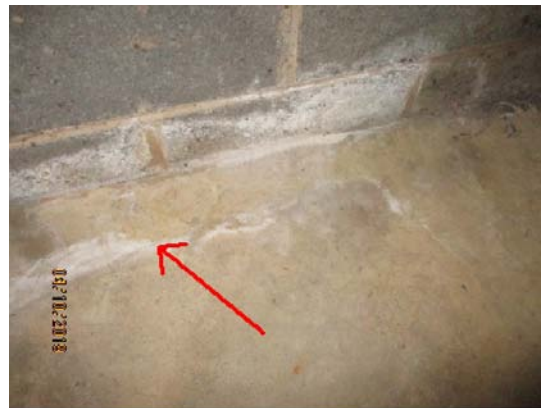
Basement Floor

The basement floor shows evidence of moisture penetration in the form of stains. Tested with moisture meter. Up to 100% moisture noted. It should be understood that it is impossible to predict the severity or frequency of water and moisture penetration on a one time visit. Virtually all basements exhibit signs of moisture penetration and virtually all basements will indeed leak at some point and time. Basement leakage rarely affects the structural integrity of a home.

Recommend having a qualified water proofing contractor evaluate and make any further recommendations prior to closing.

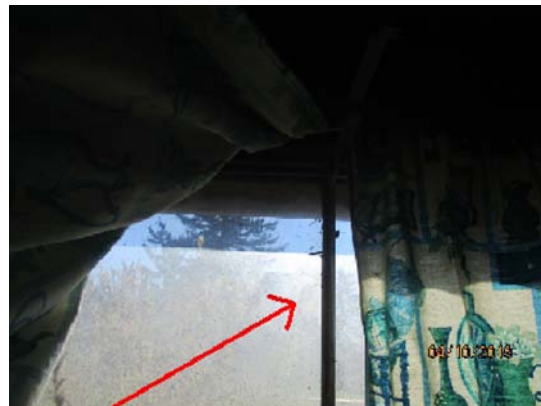
Basement Windows

Right front basement window will not open.

Recommend having a qualified window contractor repair as needed prior to closing.

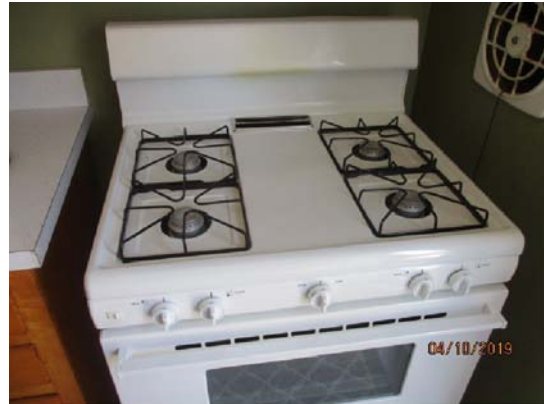
No anti tip device installed. This is a safety concern.

Recommend having a qualified contractor install a anti tip device prior to closing.

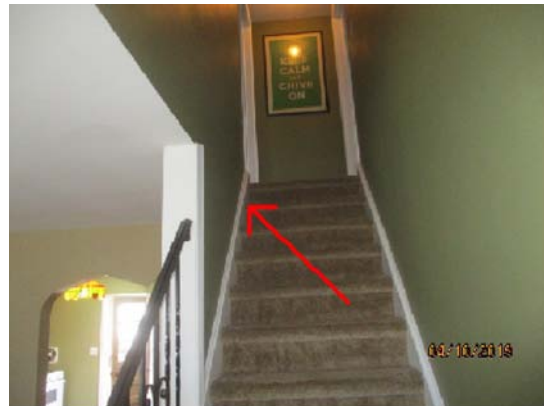
Stairways

Handrail leading to second floor does not go all the way to the top. This is a safety concern.

Recommend having a qualified contractor repair as needed prior to closing.

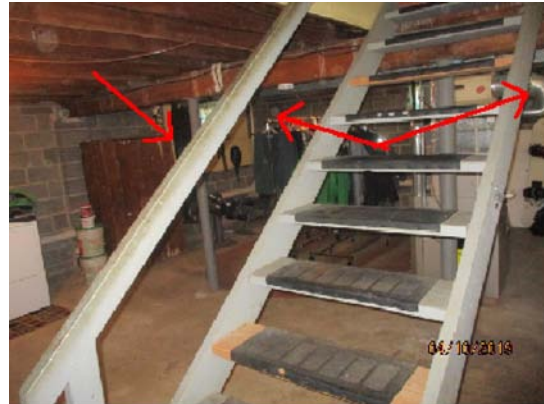
Steps leading to basement the handrail is loose, is not graspable and it is open on both sides. These are safety concerns.

Recommend having a qualified contractor install a graspable handrail and spindles or close off the both sides so kids don't fall threw prior to closing.

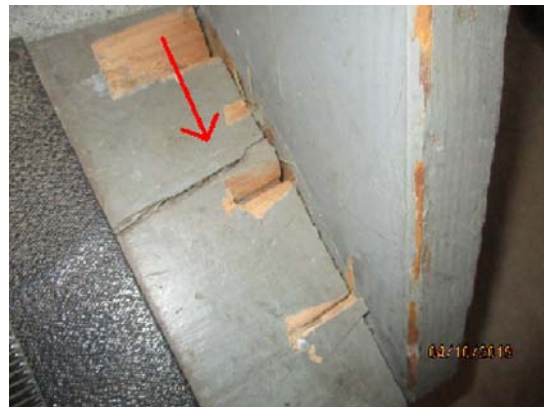
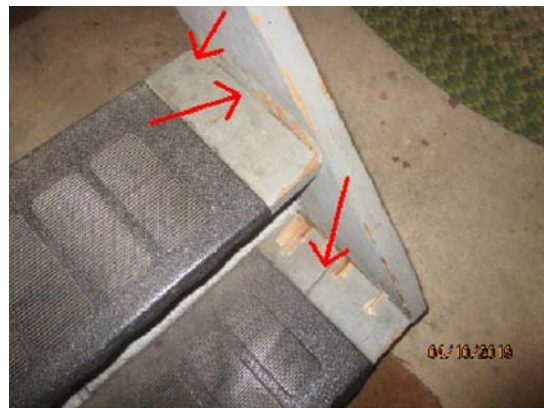
Miscellaneous 1

Basement steps move when you walk down them, several boards are cracked, several boards are pulling away from the stringer and second to the last step is loose. These are safety concerns.

Recommend having a qualified contractor repair as needed prior to closing.

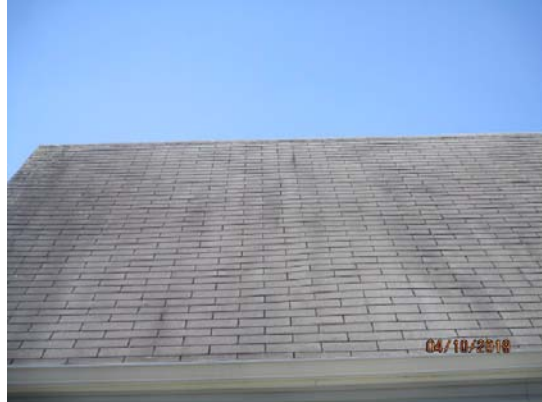
Asphalt shingles have a life expectancy of 17 to 22 years. This roof appears to be approximately 15 to 20 years old. The roof shows signs of naturally aging shingles in the form of discoloration and shingle lift.

Recommend budgeting for repairs or replacement.

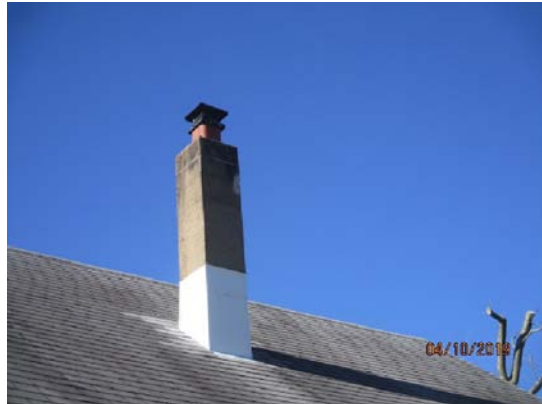
Access Restricted

Unable to view interior of chimney due to height.

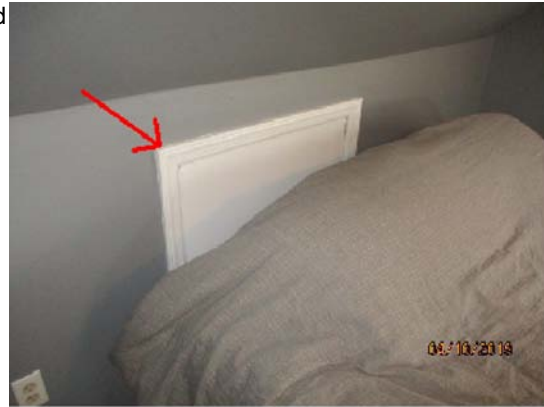
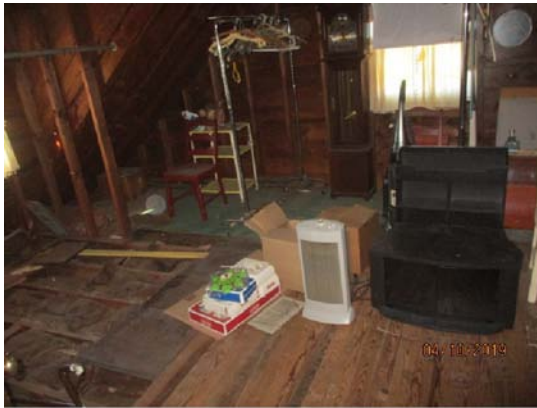
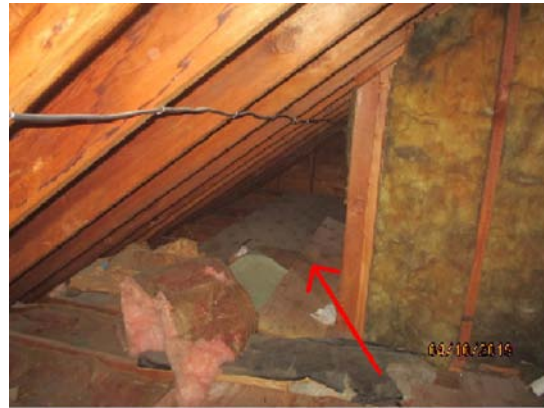
Access to knee wall is blocked with furniture. Limited view from in attic.

Access restricted in attic by limited flooring, insulation, storage and height.

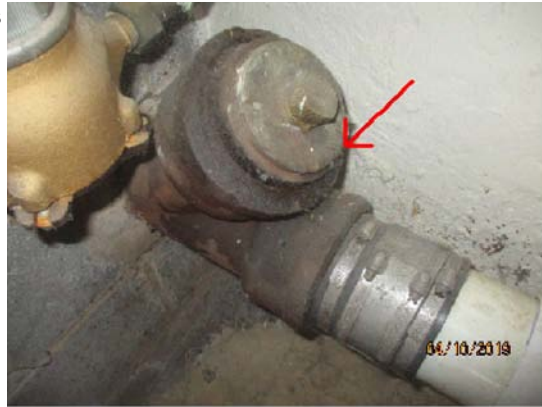
Cast iron waste pipes noted in basement. Cast iron waste pipes are very old and corrode and rusts from the inside.

Recommend budgeting for repairs or replacement of cast iron waste pipes as needed.

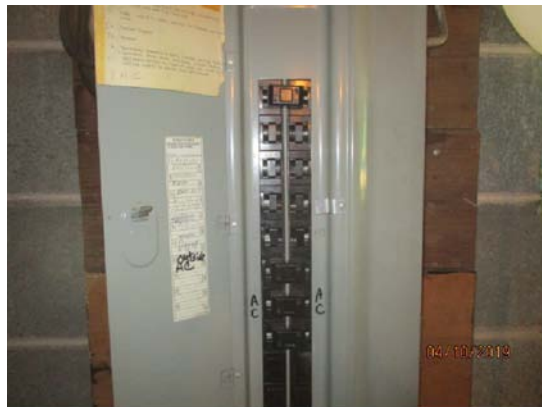
Main Disconnect

An older Pushmatic panel noted.

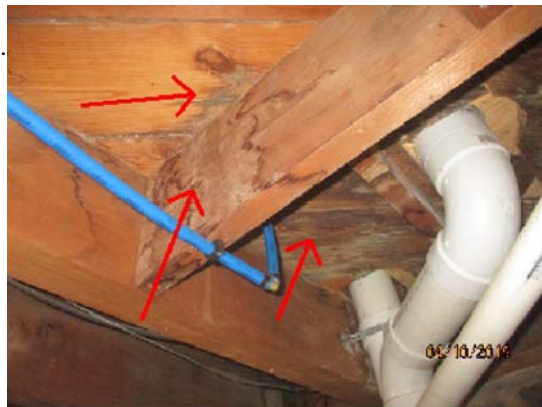
Basement Ceiling Sub Floor

Previous moisture noted on sub floor and joists below bathroom. Tested with moisture meter. Dry at time of inspection. It should be understood that it is impossible to predict the severity or frequency of water and moisture penetration on a one time visit.
