Eastern Home Inspections of NJ
3070 Route 206
Columbus, NJ 08022
609-291-1300

Client Information: Record Number E091319A

Doe, John & Mary
1 Sample Court
Sample City, NJ 00000

Inspected 9/13/19 2:00 PM

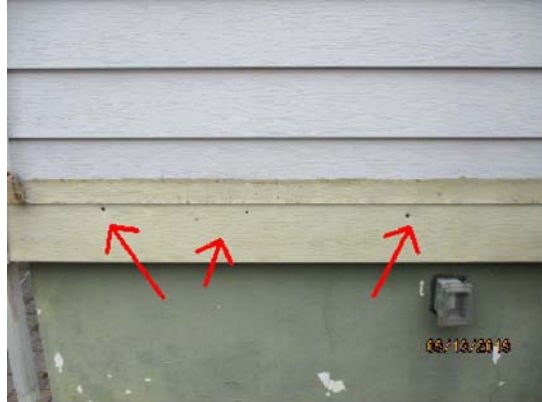
Several holes noted in siding at rear.

Recommend having a qualified contractor repair as needed to prevent water intrusion prior to closing.

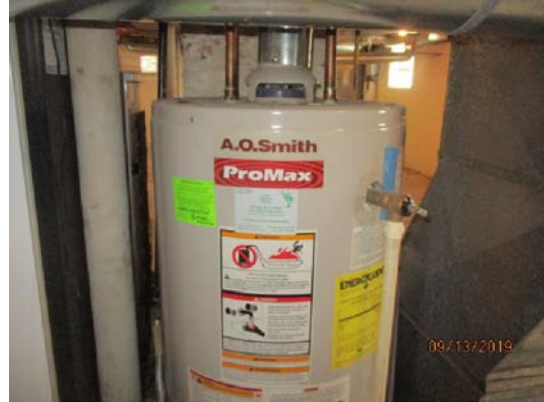
Water heaters have a life expectancy of approximately 8 to 12 years. This unit is 16 years old and is past its life expectancy.

Recommend budgeting for repairs or replacement

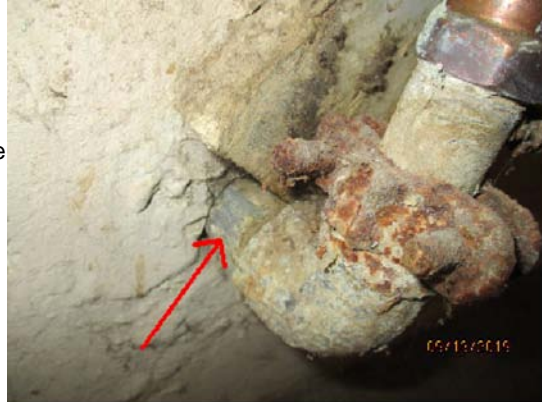
Main water supply is galvanized pipe which is very old. Galvanized pipe is known to corrode internally and restrict the water supply to the house. This older pipe can also begin leaking at any time.

Recommend having a licensed plumber replace galvanized pipe prior to closing.

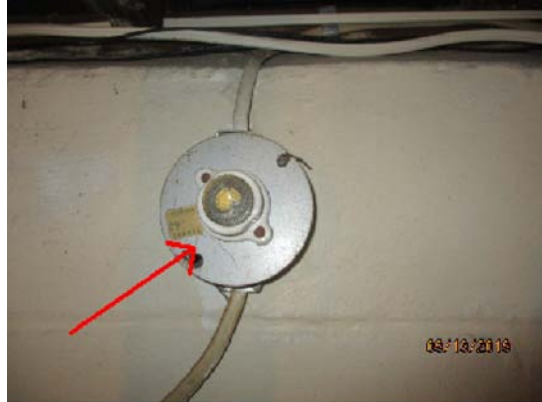
Exposed fuse noted in basement. It should be in a fuse box.

Recommend having a licensed electrician repair as needed prior to closing.

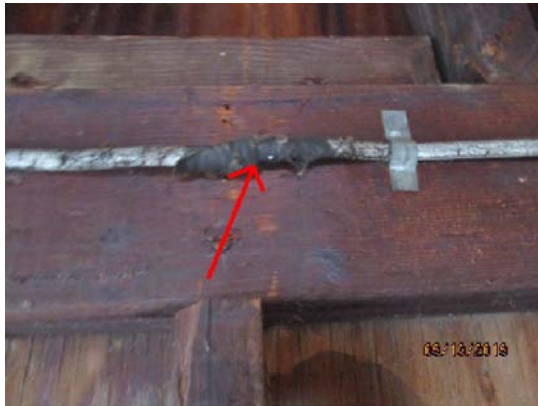
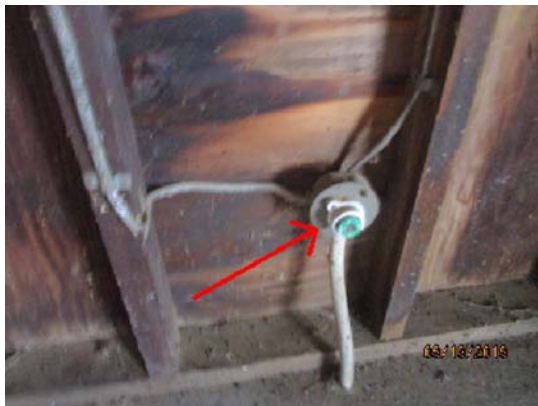
These are safety concerns.

Recommend having a licensed electrician repair as needed prior to closing.

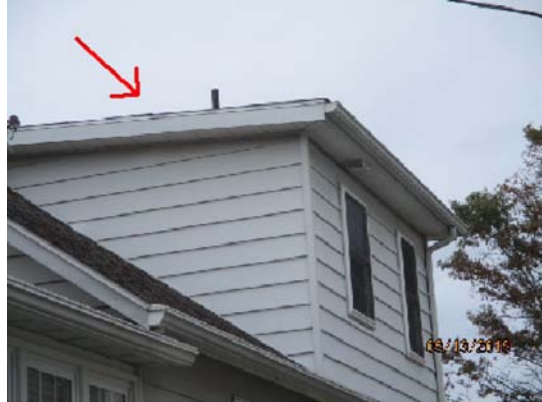
Unable to view right side upper roof due to height and pitch of roof.

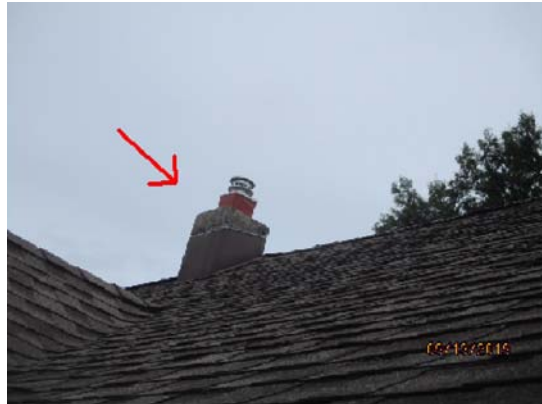
CHIMNEY

Unable to view interior of chimney due to height.

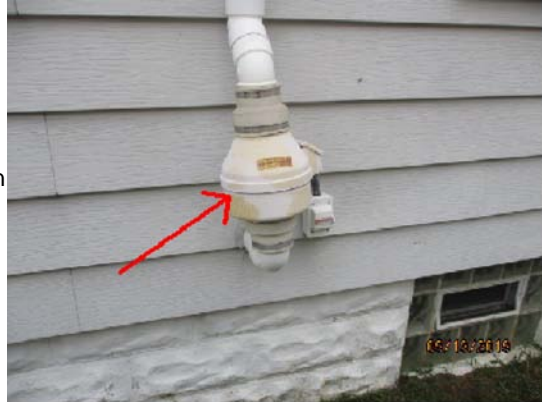
There is a sub slab suction system present that appears to be in use for the removal of radon gas. Please check with the owner for details as to its operation.

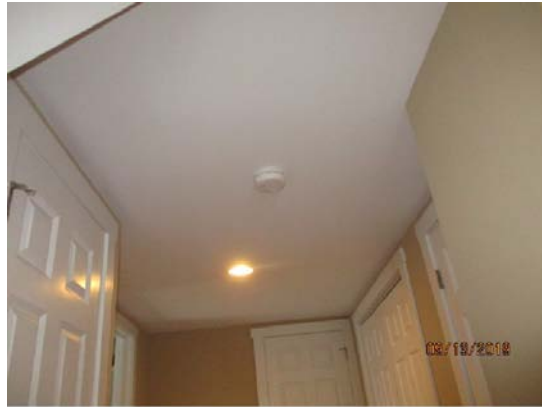
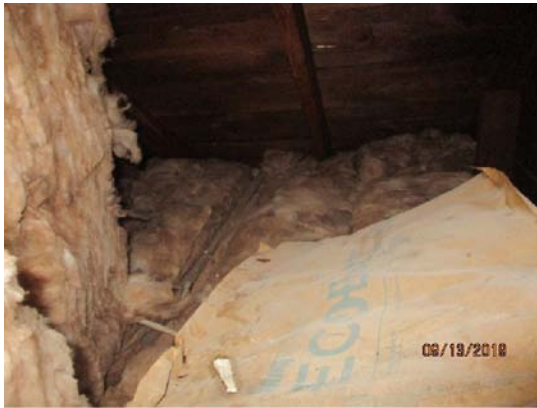
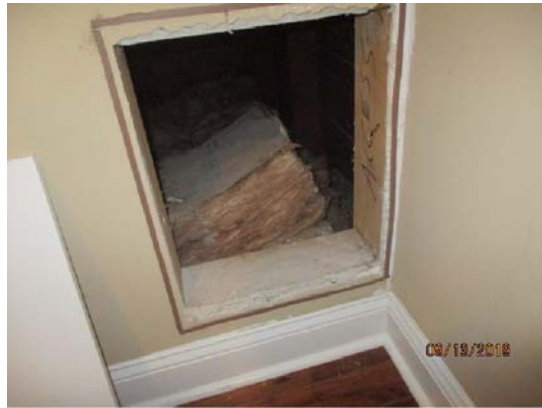
No access to upper attic and it was not inspected.

Access restricted in knee walls due to no flooring, height, insulation and hatch openings too small. Inspected from hatch openings only.
