Eastern Home Inspections of NJ
3070 Route 206
Columbus, NJ 08022
609-291-1300

Client Information: Record Number E041019b

Inspected 4/10/19 9:00 AM

Inspection Summary

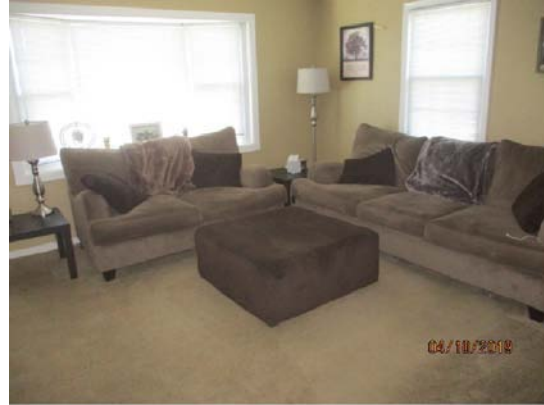
INTERIOR ROOMS

Furniture and or storage throughout rooms obstruct our views and access. Carefully inspect these areas on your pre settlement inspection.

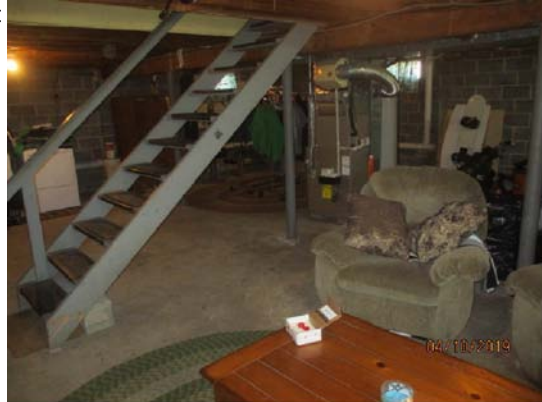
BASEMENT

Storage and other obstructions limit our views. Carefully inspect these areas during your pre-settlement inspection.

Previous moisture noted on sub floor and joists below bathroom. Tested with moisture meter. Dry at time of inspection. It should be understood that it is impossible to predict the severity or frequency of water and moisture penetration on a one time visit.
